**GEOTECHNICAL ENGINEERING CONSULTATION
MIDDLE SCHOOL BUILDING DISTRESS
COLORADO SPRINGS CHARTER ACADEMY
2555 NORTH CHELTON ROAD
COLORADO SPRINGS, COLORADO**

CTL|T Project No. CS19781.000-125

Draft Date April 12, 2024

CTL|Thompson, Inc.

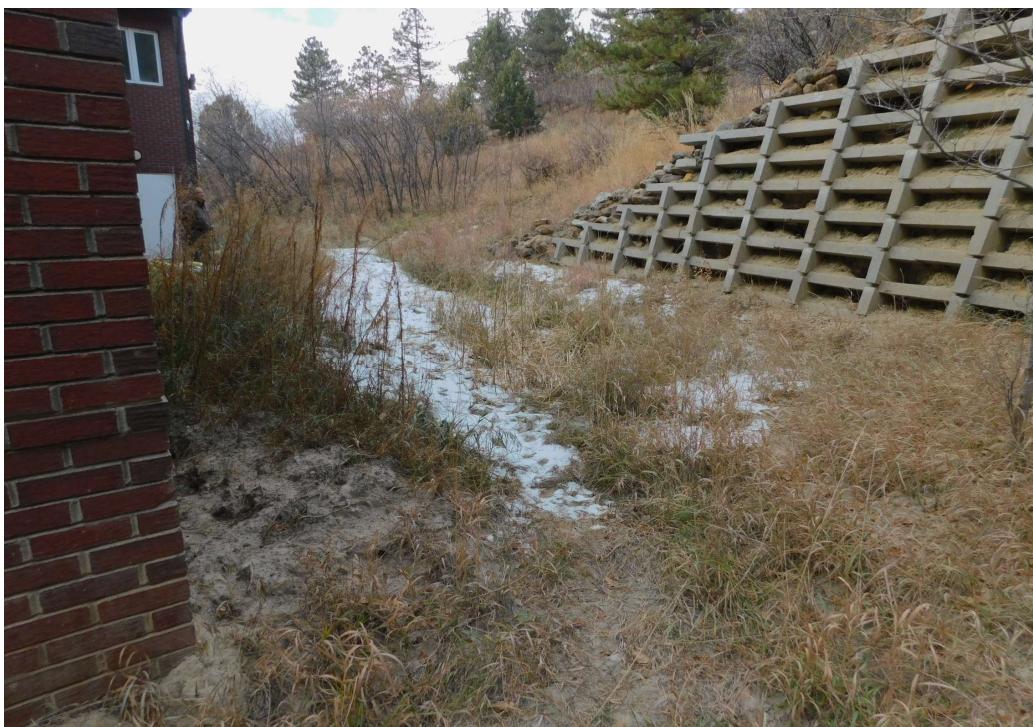
4. View of the north side of the building from near the northeast corner. Concrete crib retaining wall present on the right. Poor drainage conditions throughout.

Surface drainage around the existing building must be significantly revised to avoid ponding of water near the building. This will likely include a storm drain system along the north side of the building and with the courtyard between the wings. Construction of new retaining walls may be needed at the toe of the north slope to establish proper drainage. As plans develop, we can provide criteria for retaining walls.

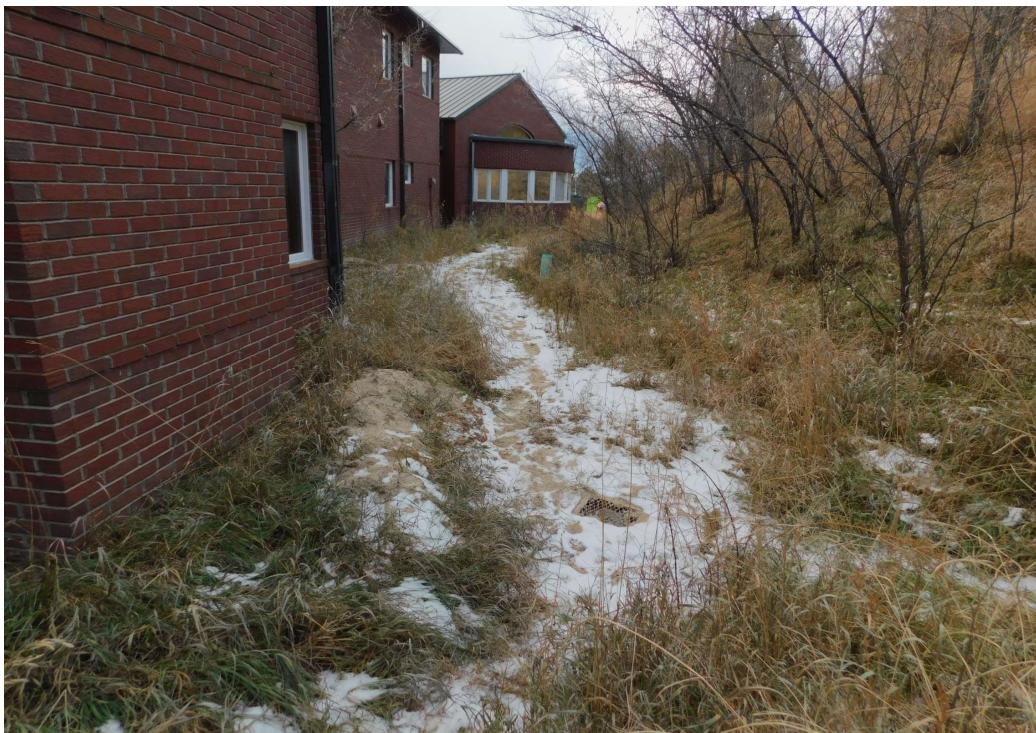
5. North side of the building viewed from outside of the north wing foyer. Existing poor drainage conditions throughout the area.

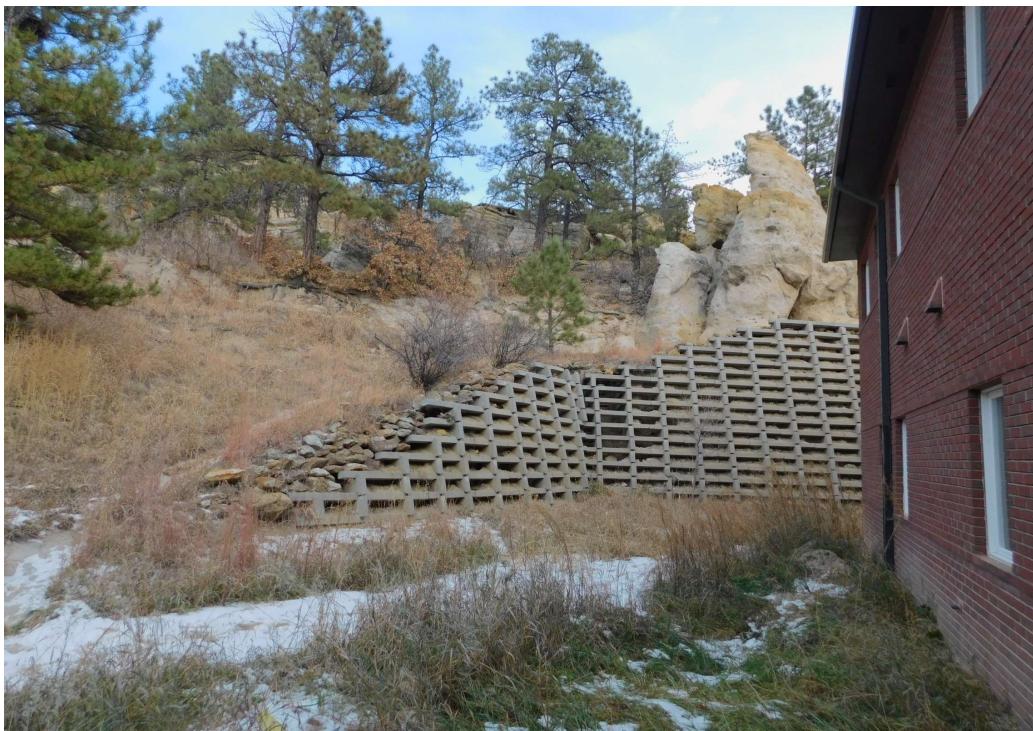
7. Northeast corner of the building. Crib retaining wall and poor drainage conditions.

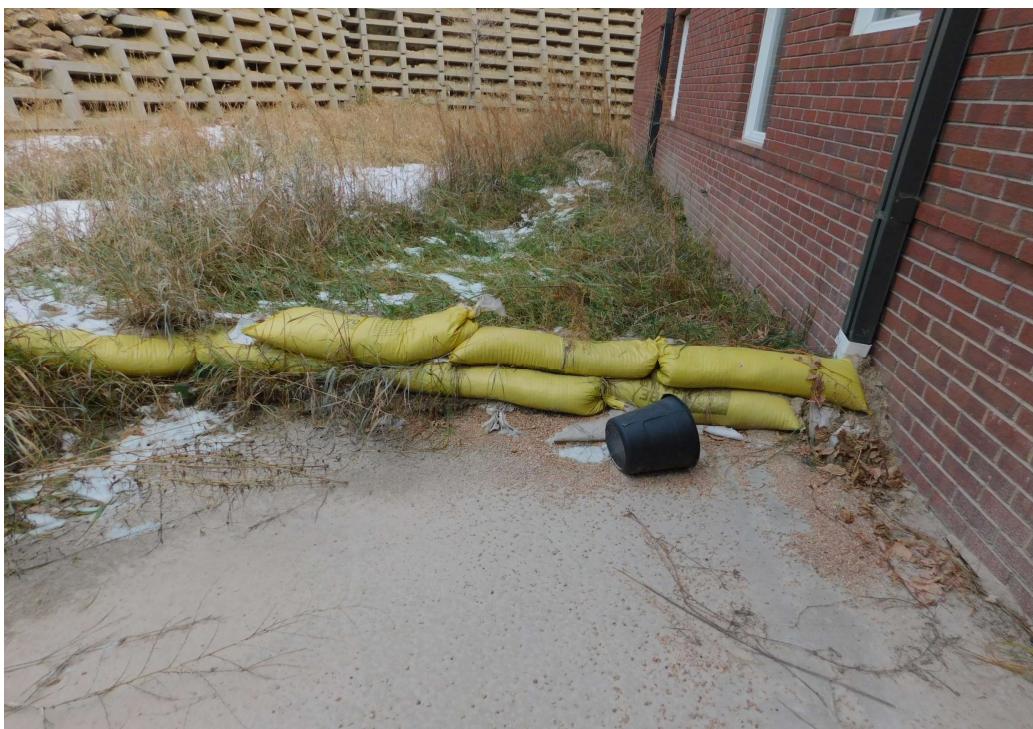
Surface runoff from the north has no defined diversion around the building, either by storm water system, or surface drainage features. Rather, it is abruptly interrupted by the school building. Significant erosion of the slope to the north has occurred and has resulted in sediment deposition along the north side of the school. Minor flooding has occurred on several occasions.

8. Poor drainage patterns along north side of the school.

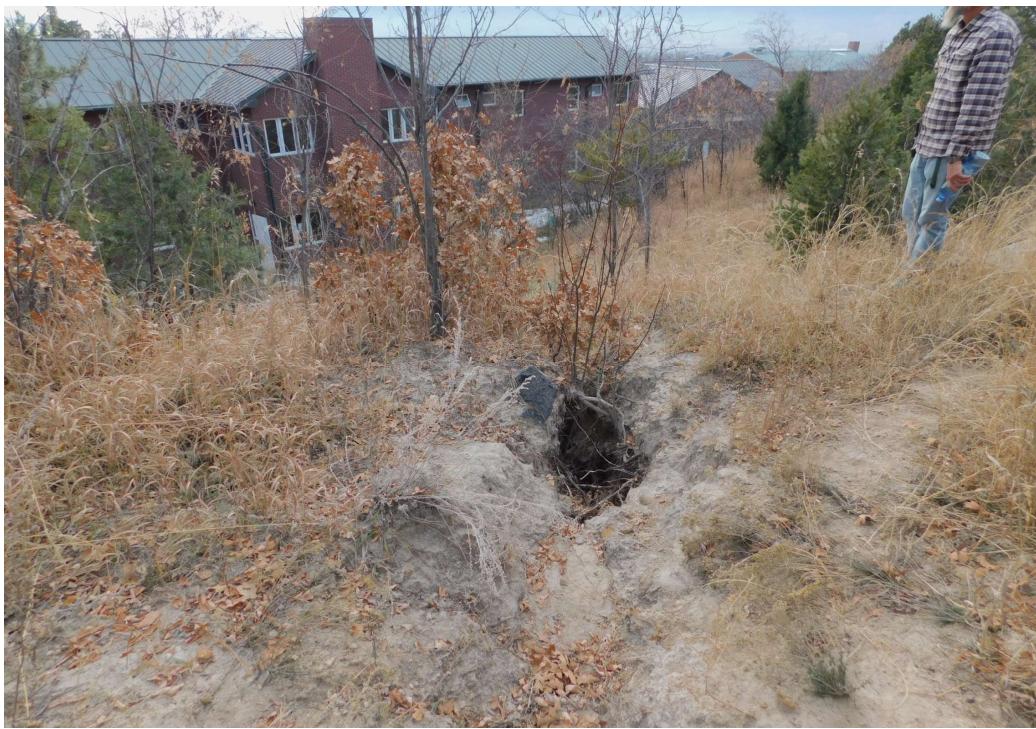
9. Stormwater pond on slope of Palmer Park. Erosion channel forming from uncontrolled stormwater runoff from the slope and out of pond toward school building.

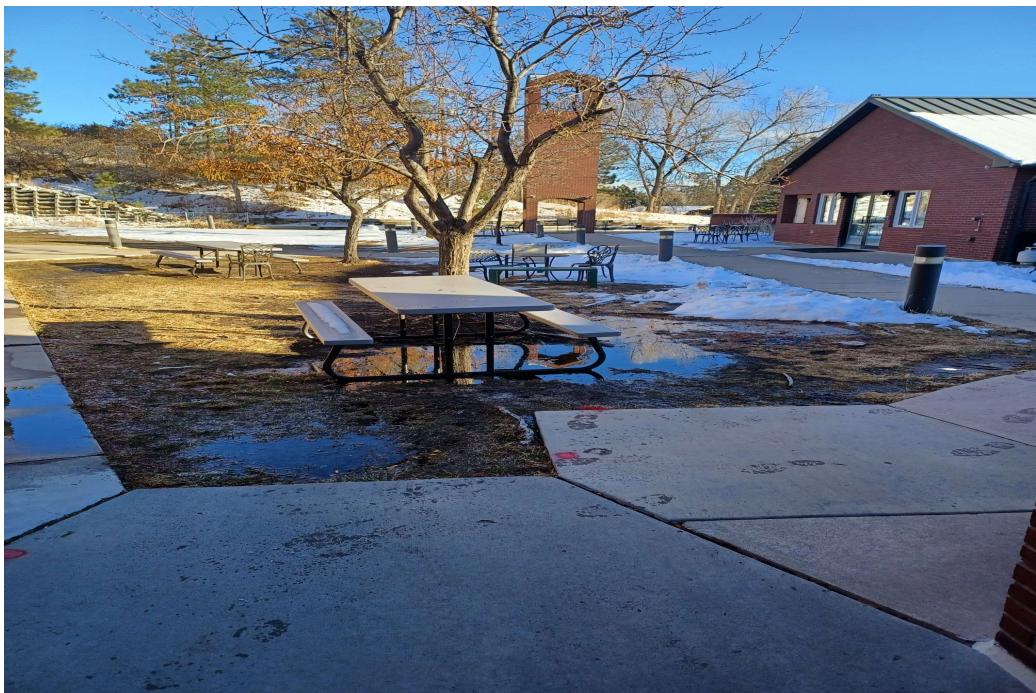
The centrally located courtyard is relatively flat and covered with concrete walks and irrigated sod. Drainage within the courtyard is such that ponding of stormwater runoff within the courtyard is common.

10. Poor drainage within the patio/courtyard.

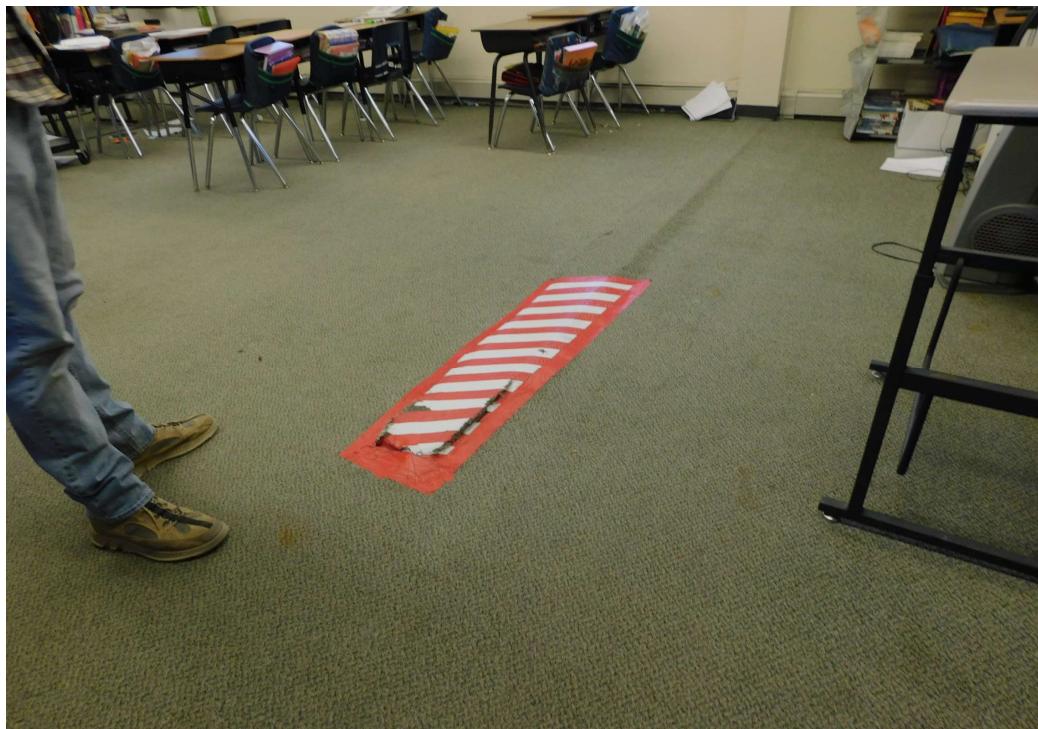
11. Vertical displacement of floor slab at grade beam in classroom 308.

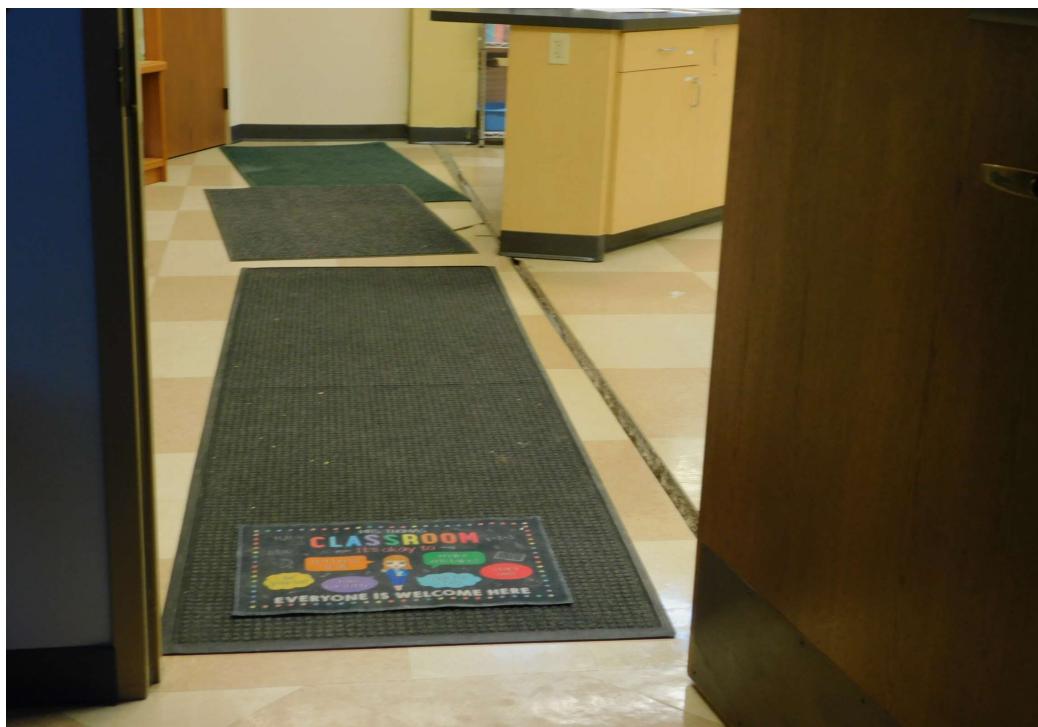
12. Floor separation at control joint in science room.

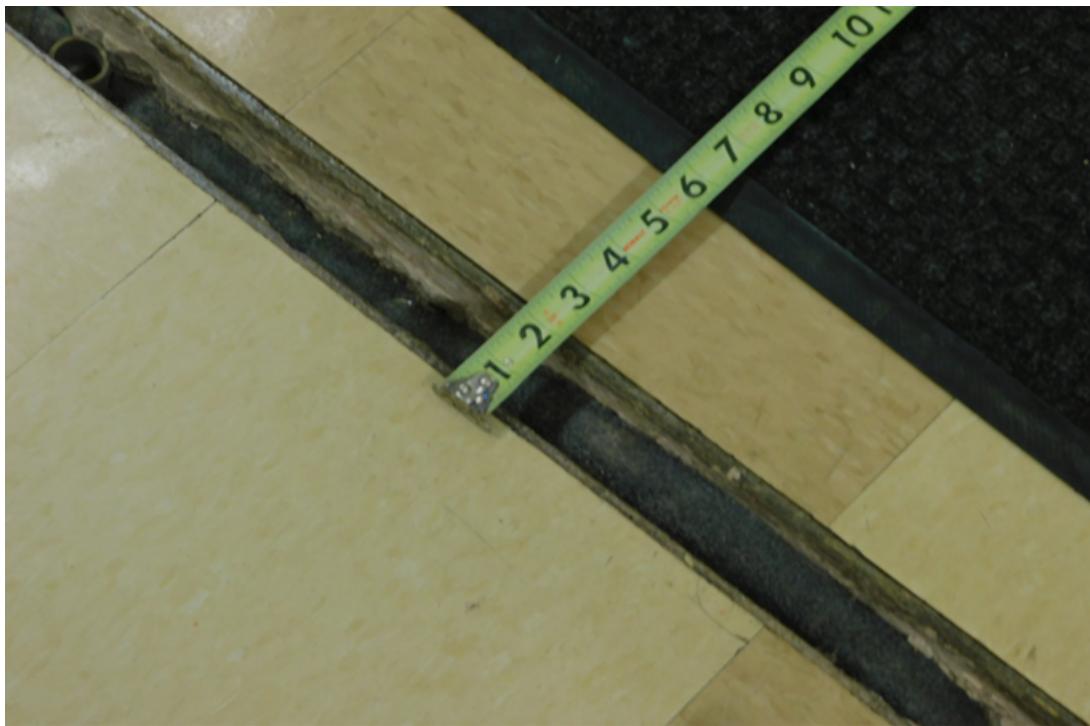
13. Floor slab separation in science room.

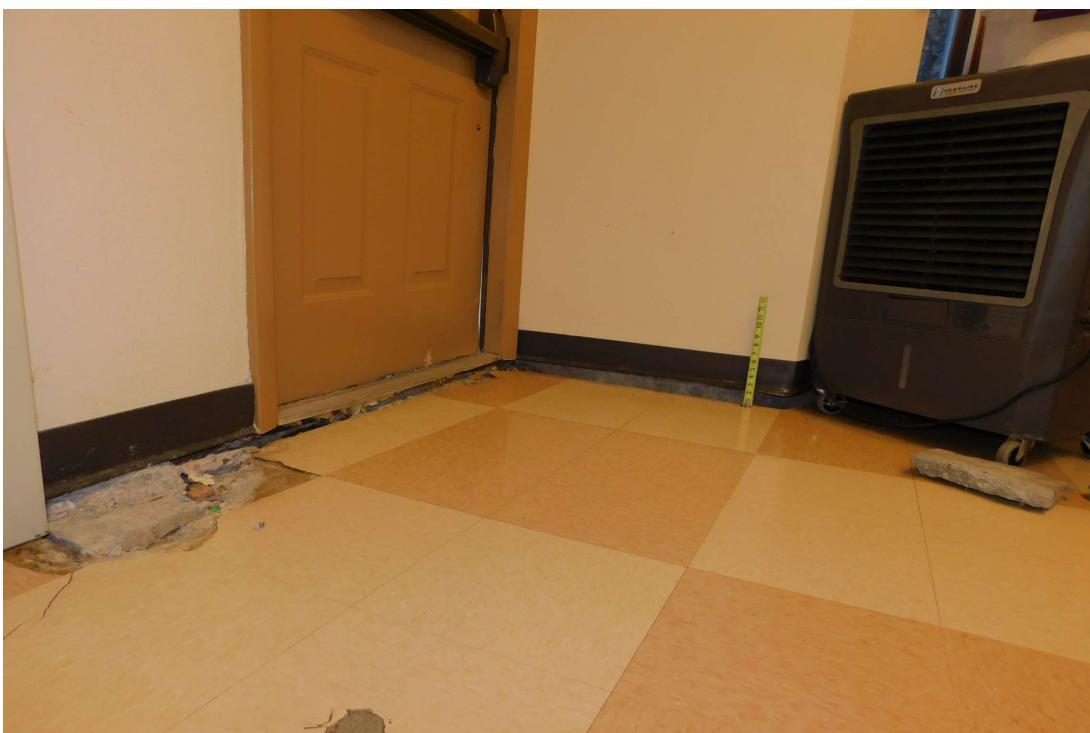
14. Slab damage at slab edge located at the northwest door of the science room.

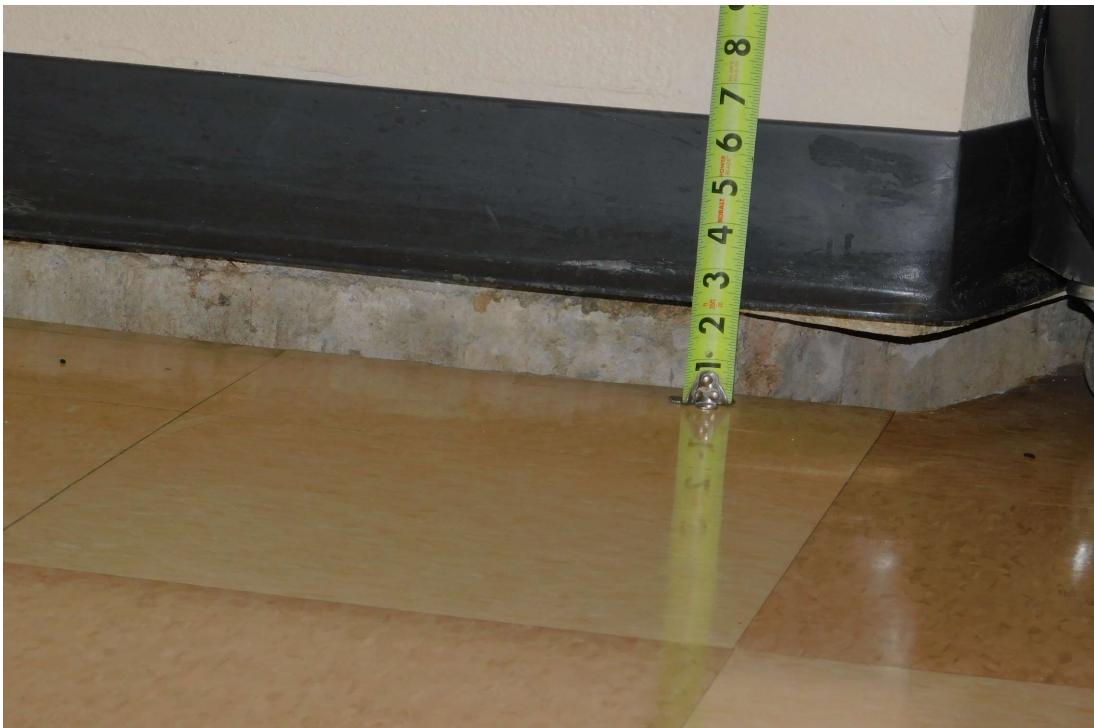
15. Slab settlement at northwest corner of the science room.

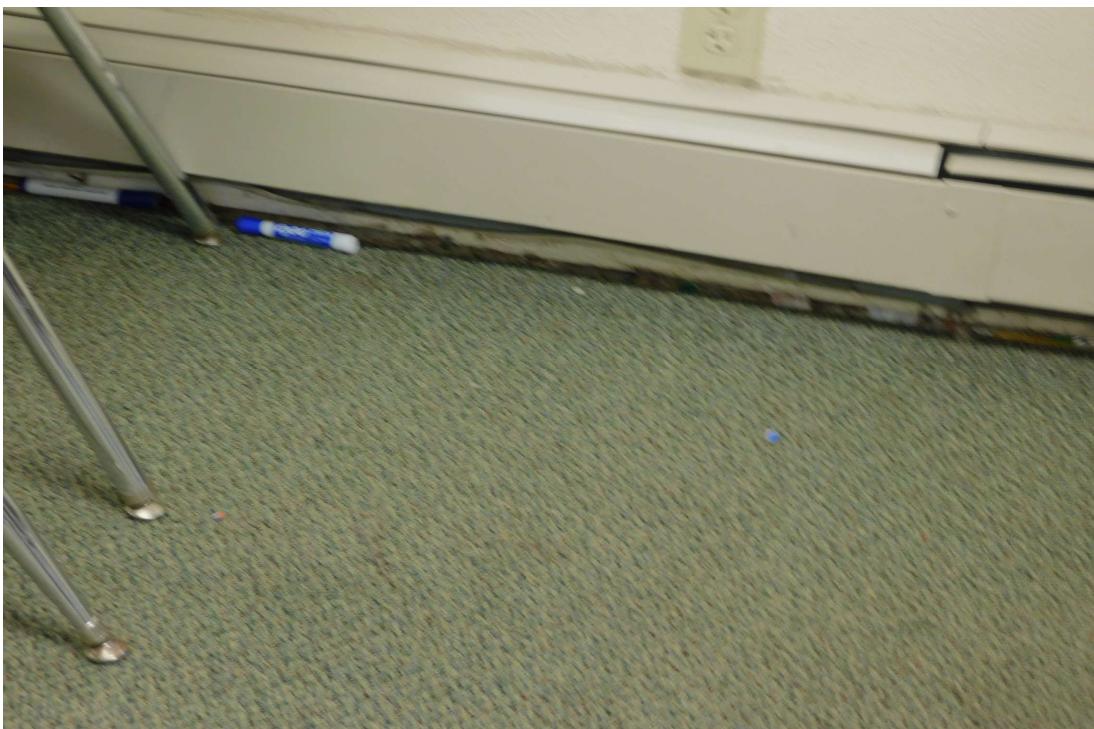
16. Slab settlement at slab edge.

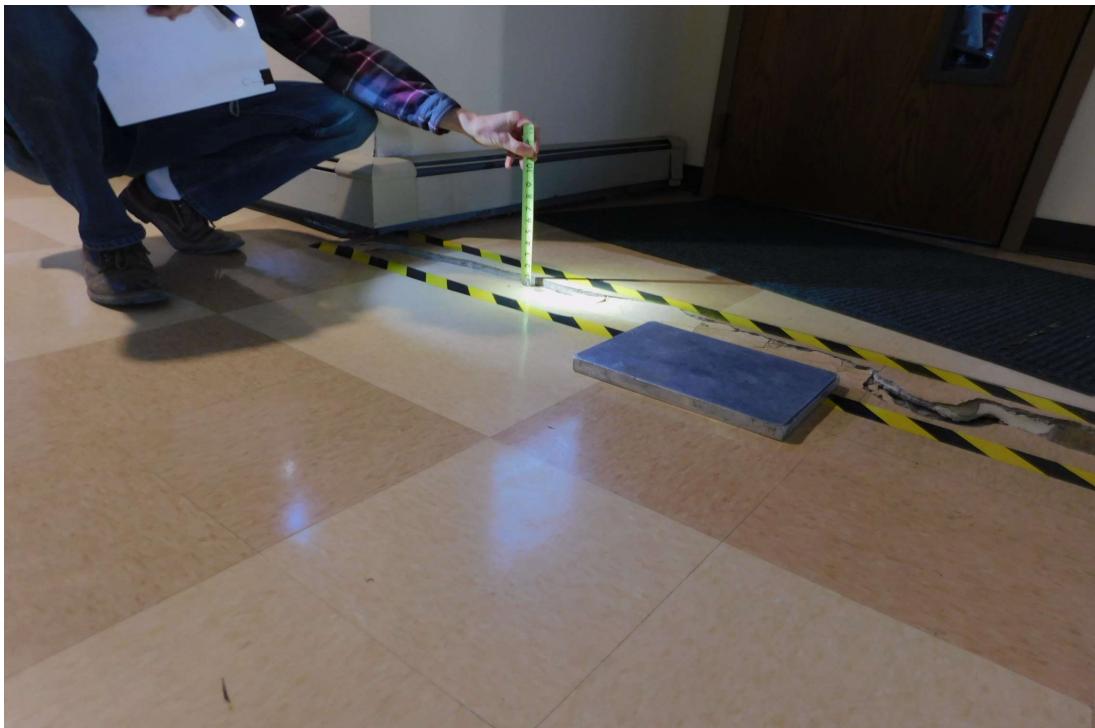
17. Vertical separation at slab control joint located at the door to classroom 308.

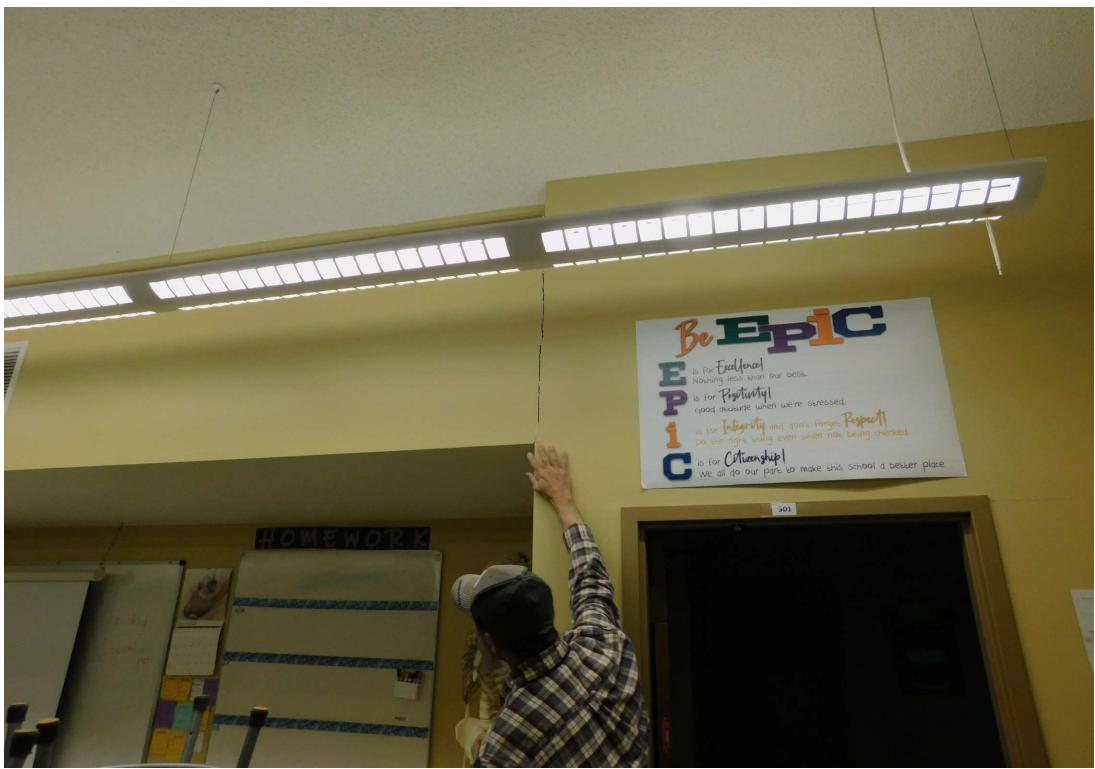
18. Drywall joint crack at door to science room.
