The Ballard Group, Inc.
Mechanical Consulting Engineers

Colorado Springs Charter Academy Mechanical Systems Assessment

June 26, 2024

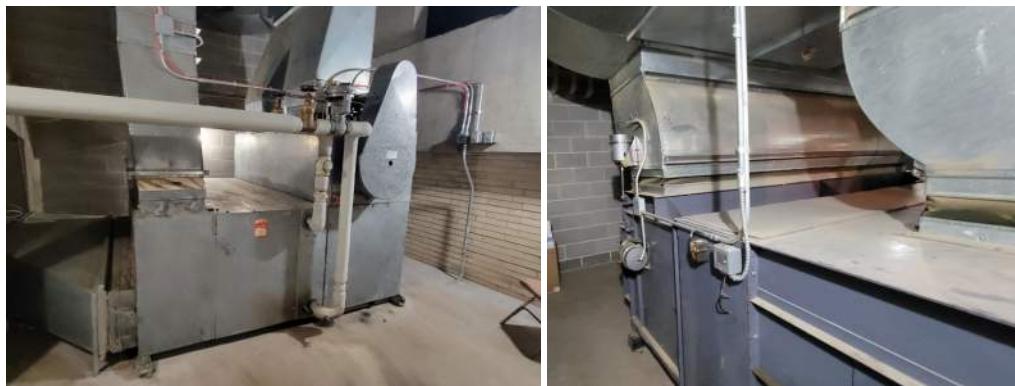
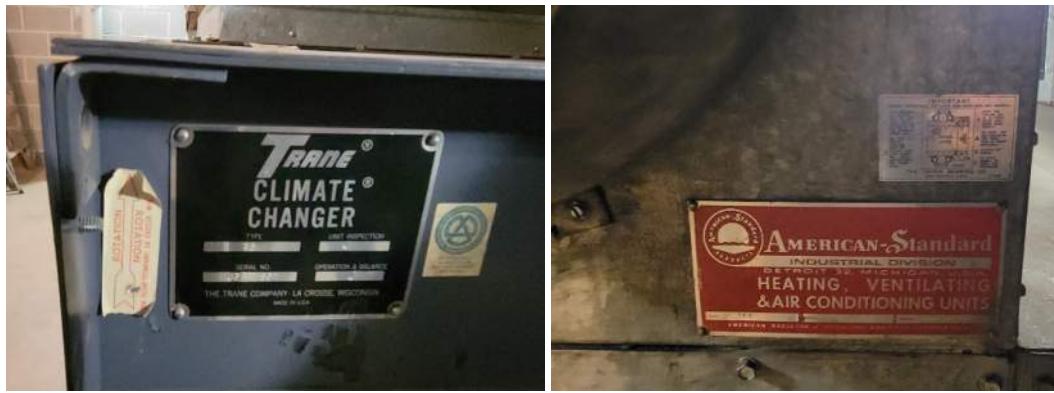
- A. Existing Conditions: The facility is currently served by the following air distribution systems.
 1. There are (6) indoor air handling units providing air distribution to the larger spaces such as Cafeteria, Auditorium, Computer Lab, Child Watch, Entry Lobby and classrooms 105,7&9. These units are constant speed, heating, and ventilation with ducted outside air. There is a heating coil with pneumatic controls.

1. The overall condition of the facility air distribution equipment is at end of useful life as most appear original to the building. Recommend all equipment should be replaced due to age and pending increasing maintenance costs.

1. Existing air distribution systems equipment, heating plant, and temperature controls systems all have surpassed the expected life and should be replaced including all the hydronic heating piping. New systems air handling equipment shall include chilled water coils for mechanical cooling.
2. Replace the indoor air handling units with new built-up air handling units and connect to existing ductwork. These new central station air handler units to be provided with a heating coil, chilled water coil, 30% filters, spring isolators, economizer controls and a supply fan with VFD will distribute a variable volume of conditioned air throughout the facility. The AHU will be single zone VAV. The existing multizone units will have cut-in VAV dampers with reheat coils added for temperature control.

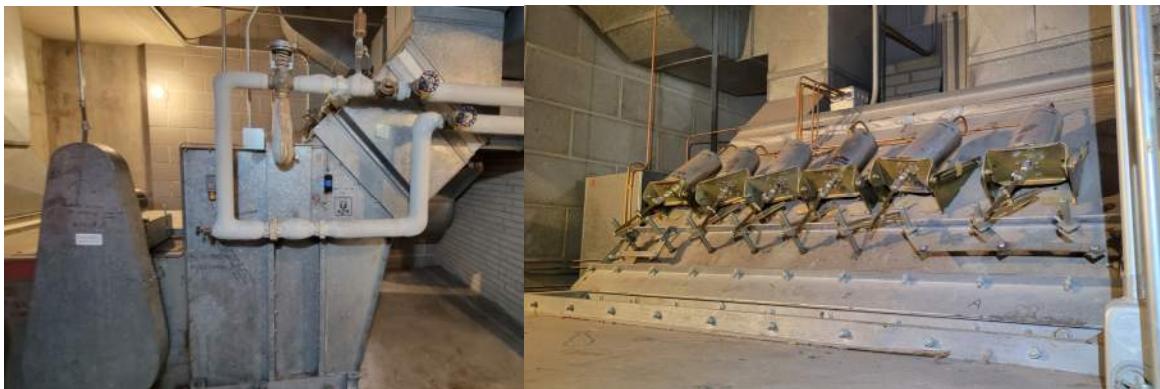
2. There are two multizone units. MZU-1 feeds underground ductwork to two zones, now classrooms 111 and 113. MZU-2 feeds underground ductwork to classrooms 101 and 103 with overhead ductwork to SPED and the Library for six zones of control.

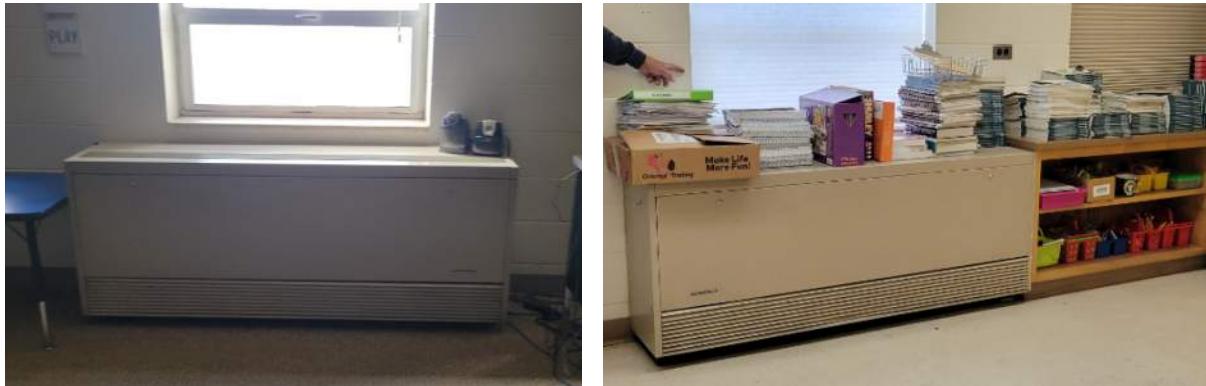
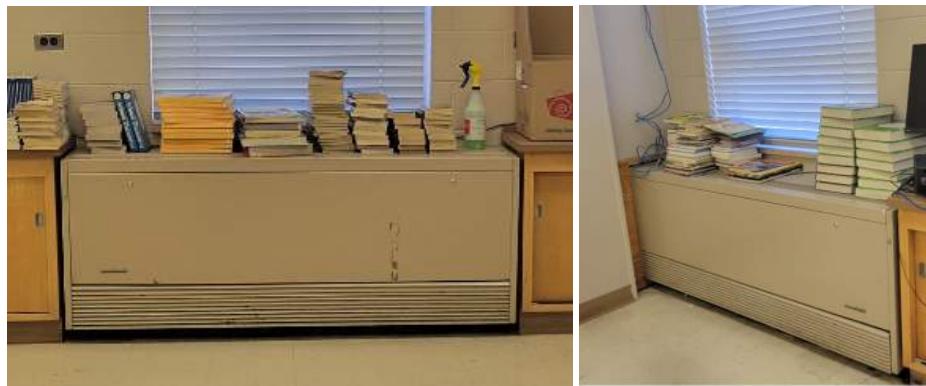
3. Unit Ventilators provide air distribution for some of the classrooms along the south exposure on both levels but only on the second level for the north exposure. First level north classrooms are fed from the multizone units. There is a total of (16) units; five (5) on first floor and eleven (11) on second floor. They all have hot water heating coil with pneumatic controls, exterior wall louver for fresh air and appear to be original to the building. They have an original scheduled capacity of 750 cfm each.

3. Replace the horizontal unit ventilators, like for like, with new units with hot water heating and chilled water coils. Provide with all new digital controls and valves. Existing wall louvers to be replaced to maximize airflow for economizer cycle, free cooling. Airflows have been increased for additional mechanical cooling be added to the system. This project to be considered a "direct" unit vent replacement with cooling added so the existing relief air path through the corridors and open stairwells can be maintained. This needs to be confirmed with local AHJ.

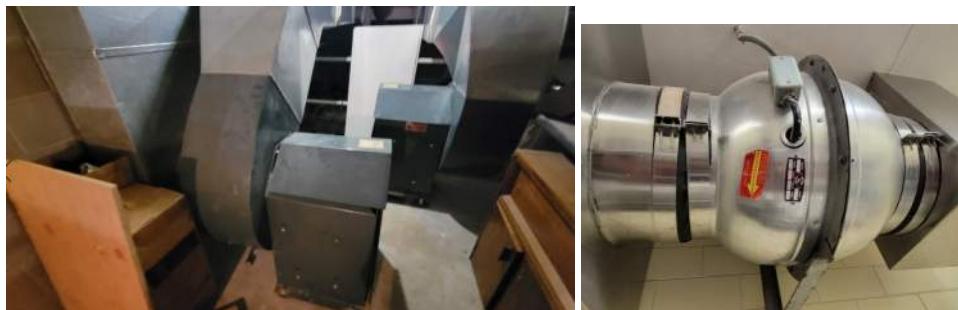
4. There are eight (8) exhaust fans for restroom exhaust, kitchen exhaust and relief air for the classroom unit ventilators. Fans appear to be original to the building.

4. All the exhaust fans observed were in fair to poor condition and nearing the end of expected life.
5. **Per ASHRAE Equipment Life Expectancy the useful life of fans and dampers is between 20 and 25 years depending on fan type.** Many of these fan systems are approaching 60 years of age and recommend that all air handling and fan systems be replaced. See appendix for ASHRAE Equipment Life Expectancy chart with highlights of associated equipment for the K-8 building.

6. Replace existing restroom exhaust fans and building relief fans with new. Existing exhaust ductwork shall be cleaned and sealed for reuse.
 - i. (E) EF-1, ceiling, 180 cfm @ 0.25" wc

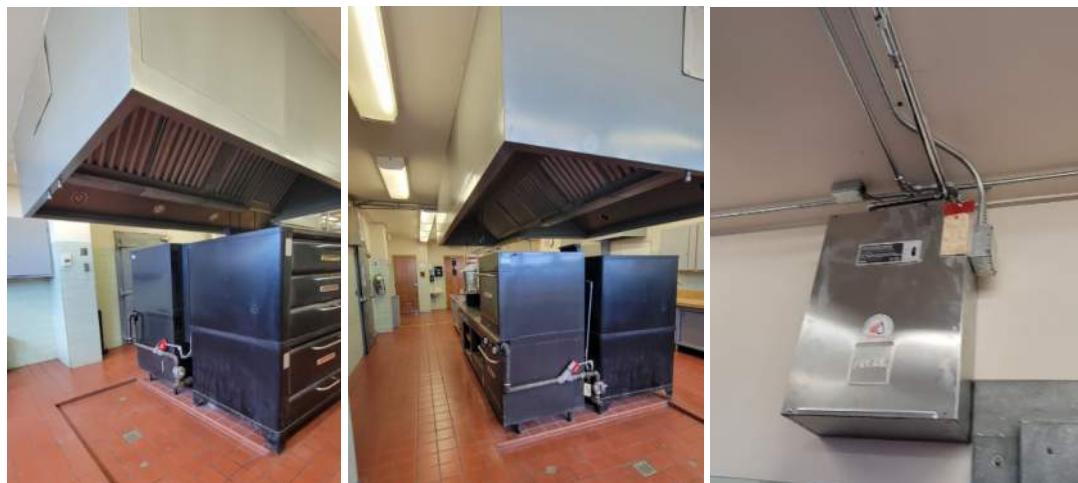
5. There are four (4) room units (heating only fan coils) in the administration spaces.
6. Remaining spaces, such as hallways, small offices and storage room not served by overhead air systems, are heated by the hot water systems using cabinet unit heaters, convectors, finned tube and unit heaters.
7. The kitchen cook line hood appears original to the building and now oversized for the cooking equipment currently beneath the hood. The grease duct makes a long run above the ceiling to the kitchen exhaust fan, on the west end of the building. Years of grease build up is concern given the long horizontal duct run. Hoods fire protection system is at end of life.

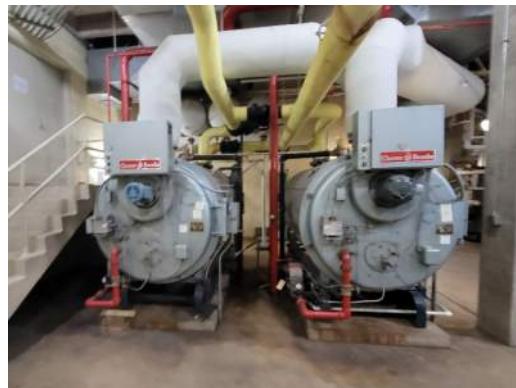
1. The building is heated from a pair of Clever Brooks power vented fire tube, gas-fired boilers which are original to the building, installed in 1966. The heating plant is installed in the original boiler room, as shown on the existing drawings. After expensive repairs, both boilers are still operational. Each boiler is listed at 4,184 MBH input. Per school facilities, only one boiler is needed to maintain the school's temperature in the winter.

1. The boiler system is operational but long overdue for replacement due to the age of all the equipment and pending increasing maintenance costs.
2. **Per ASHRAE Equipment Life Expectancy the useful life of steel fire-tube boilers is 25 years, base-mounted pumps is 20 years as well as hot water coils is 20 years. This system is approaching 60 years of age and recommend the entire hydronic heating system be replaced.**

1. While the heating water plant is functional, it is well past its recommended useful life and provisions shall be made for the entire system replacement. A new high efficient boiler plant is recommended.
2. The distribution piping is original, at nearly 60 years of age a complete piping replacement is recommended.
3. Replacement boiler system narrative:
 - i. Heating Source: Provide (2) condensing boilers provided for high efficiency heating (96.2% thermal efficiency) and additional redundancy. These boilers shall be provided with external primary circulation pumps installed by mechanical contractor. System shall be designed for 150°F EWT and 110°F LWT to provide condensing efficiency throughout the heating season. Boilers

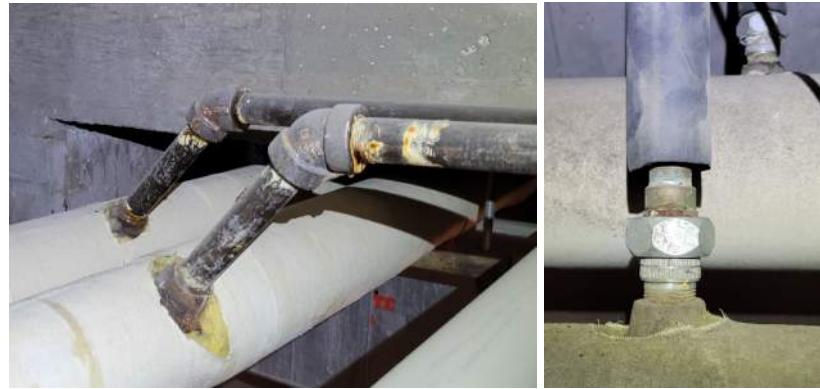
2. The hydronic piping has steel mains and soft copper tubing, all heating mains appear original to the building and installed in the accessible crawlspace.

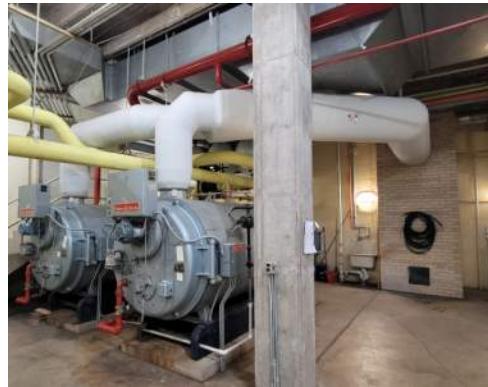
3. The boiler flues are sealed, pressure rated flues wrapped with insulation and terminates in the existing brick chimney.

shall utilize natural gas fuel, like the existing boilers. The flue and combustion air shall be direct vented to the outside, up through the first level in a new chase and terminate sidewall. System shall be provided with 30% propylene glycol for freeze protection. Glycol feeder, chemical pot feeder, expansion tank, and air/dirt separator shall be provided with the new boiler plant.

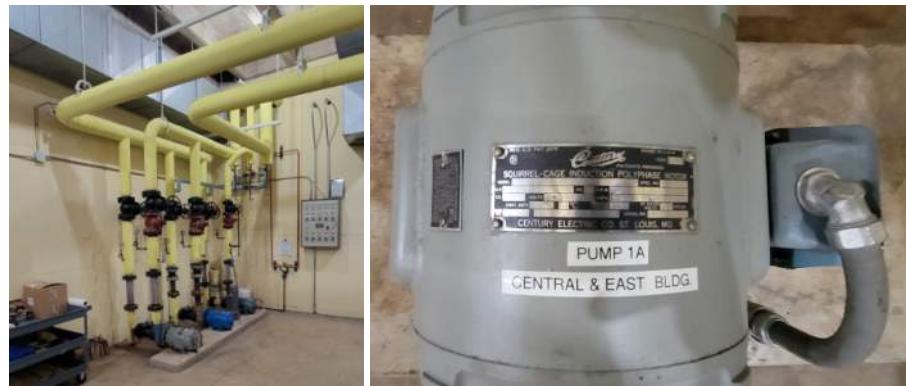
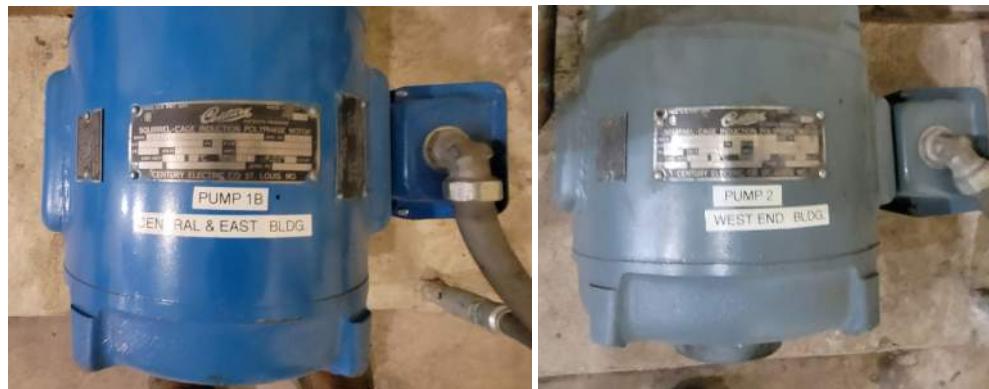
4. The heating water circulation is by three base mounted pumps. Primary/standby for the central/east loop and a lone pump for the “west end” building. There are no dedicated boiler pumps so only a primary pumping system. These pumps appear to be original with various motors changed out over time.

ii. Distribution: Proposed system utilizes variable flow pumping with two (2) pumps sized for parallel (lead/lag) operation. Wall mounted variable frequency drives shall modulate the speed of the secondary pumps to meet the instantaneous heating load in the building. Pumps shall be vertical inline split-coupled construction. These two building pumps will feed the entire building, eliminating the need for the single “west end” pump.

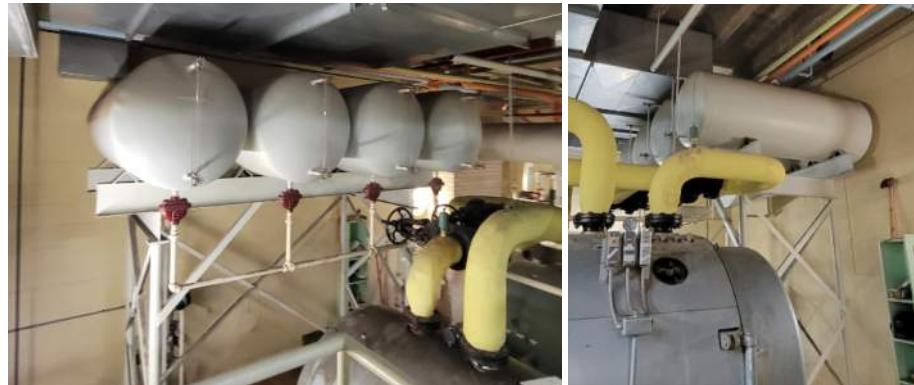
5. Combustion air is drawn into the boiler room by a 50x24 combustion air duct in the northwest corner of the boiler room with high and low openings into the room. There is a louver to the outdoors above grade on the north façade.
6. There are four expansion tanks mounted on a metal stand behind the boilers.

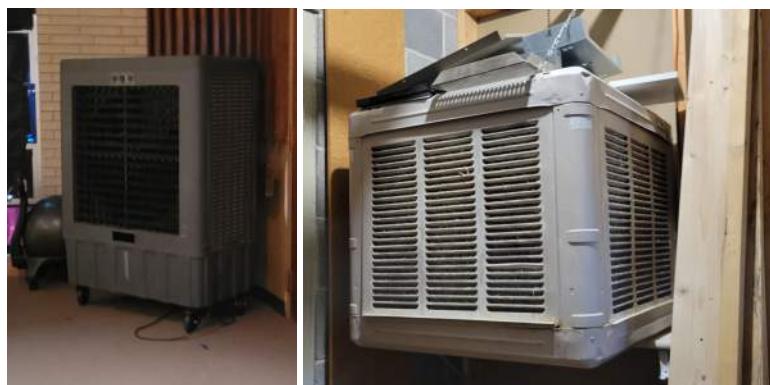
1. The building has no mechanical cooling.
2. The original 1965 drawings indicated three alternates for a chilled water cooling system with indoor chillers and remote cooling tower, but no such equipment was found on site, so the alternate must not have been accepted.
3. Several portable cooling units were seen around the building.

1. Install a new chilled water system to provide mechanical cooling for the entire building. Install one (1) new 120 ton air-cooled scroll compressor chiller on new concrete pad on grade north of the existing building, far west end. Provide new chiller enclosure to secure the equipment from children. Install 5" directed buried chilled water mains from the chiller into the existing boiler room.

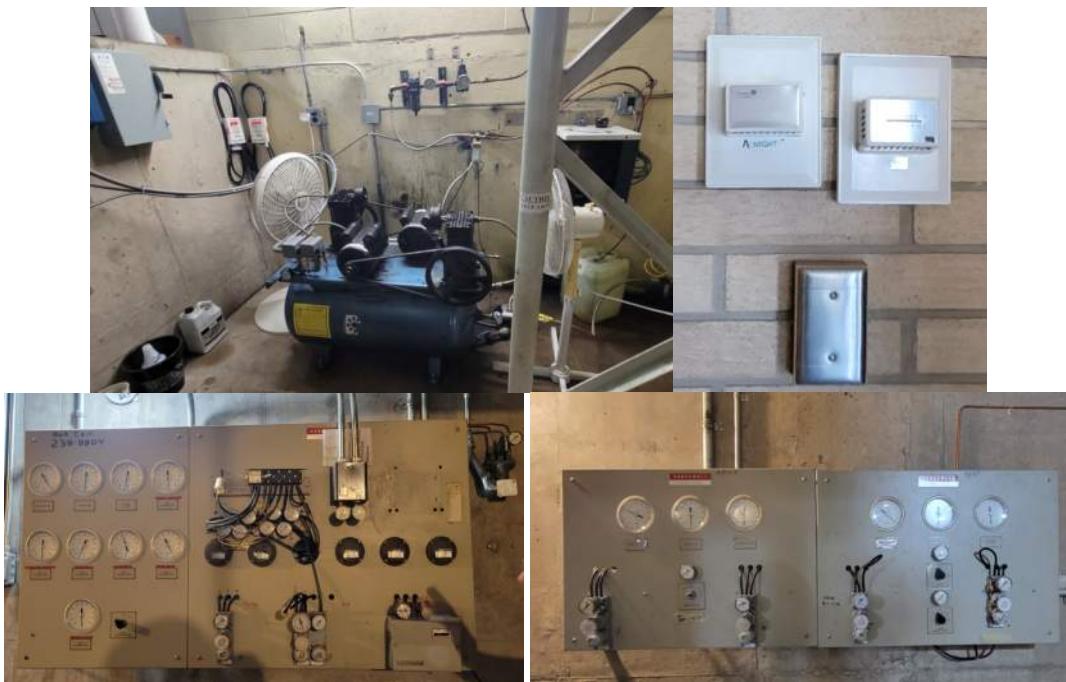
1. The original pneumatic control system installed when the building was originally built is still in operation today. The system has been maintained well enough through the years that it remains functional.

1. The pneumatic controls system appears to still be operational, with some manual operations needed to maintain space temperatures. Heating valves fail open, so when they fail, the occupants feel the results as the space becomes very hot. [Finding qualified service technicians to maintain a pneumatic system is getting harder and harder as this controls technology is seldom used much anymore.](#)
2. Per ASHRAE Equipment Life Expectancy the useful life of a pneumatic control system and pneumatic valve actuators is 20 years. This system is approaching 60 years and needs to be replaced along with all the HVAC equipment.

1. Provide a new Direct Digital Control (DDC) system shall provide the basis of the temperature control system. The system will be computer based and will allow for the mechanical systems to be controlled and monitored from a remote location or from within the building itself. Provide a full graphics package. All new mechanical equipment listed above shall interface with and be controlled through the new Building Automation System (BAS) system with the following exceptions:
 - a. Exhaust fans for individual/remote toilet rooms.
 - b. Sewage Ejector/Sump Pumps.
2. Remove all the existing pneumatic controls, compressor, piping, hangers, stats, etc.

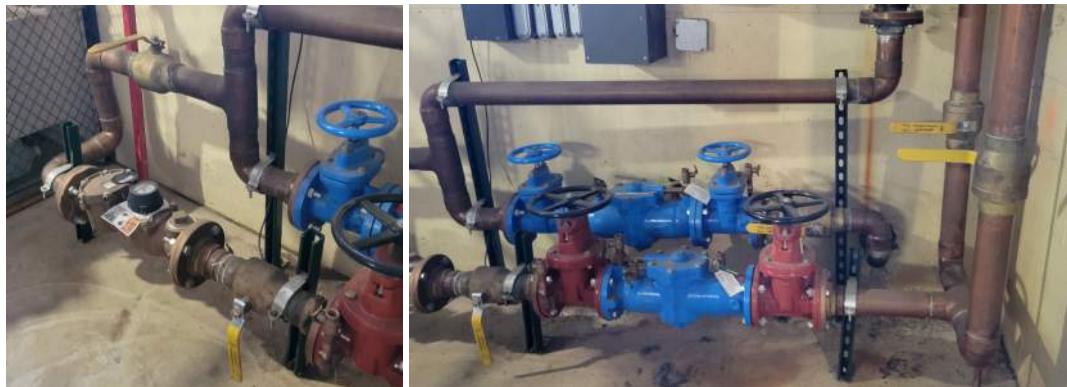
1. The building is served by a 3" domestic service that enters the basement in the southwest corner of the building. The water entry backflow preventer and indoor water meter have been upgraded at some time and appear compliant with current codes. There was no pressure gauge on the water entry but water pressure at the middle school, up the hill, was over 100 psi. If pressure is over 80 psi, a pressure reducing station is required. All observed water piping in the facility appears to be hard copper piping. Most of the distribution piping appears original to the build based on the pipe insulation.

1. The original copper water piping is in fair condition. There are signs of leaks and repairs made around the building. The copper piping is past its useful life.
2. The waste and vent piping is in fair condition. There are signs of leaking joints and prior repairs made around the building. The waste and vent piping is past its useful life.
3. Natural gas piping is showing signs of age but appears to be in good working order.

1. Install a pressure reducing valve at the water entry into the building, set to 80 psi.
2. Replace all the original domestic water piping due to age.
3. Replace all the original waste and vent piping due to age. New vents through roof to be 3" minimum.
4. Install a properly sized grease interceptor for the kitchen.

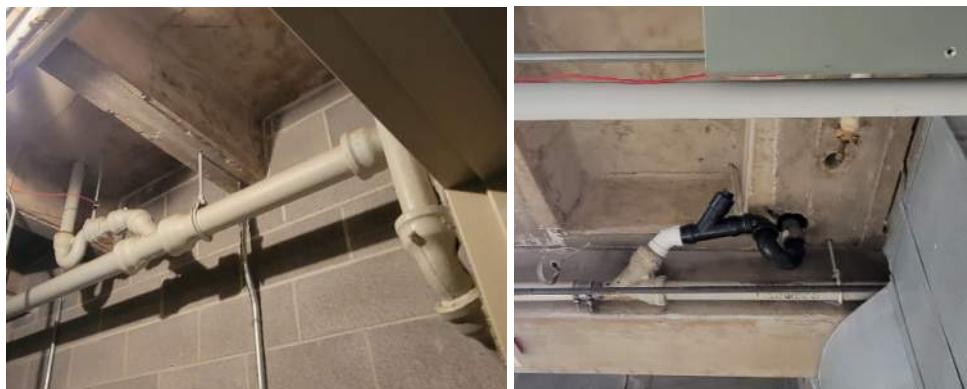
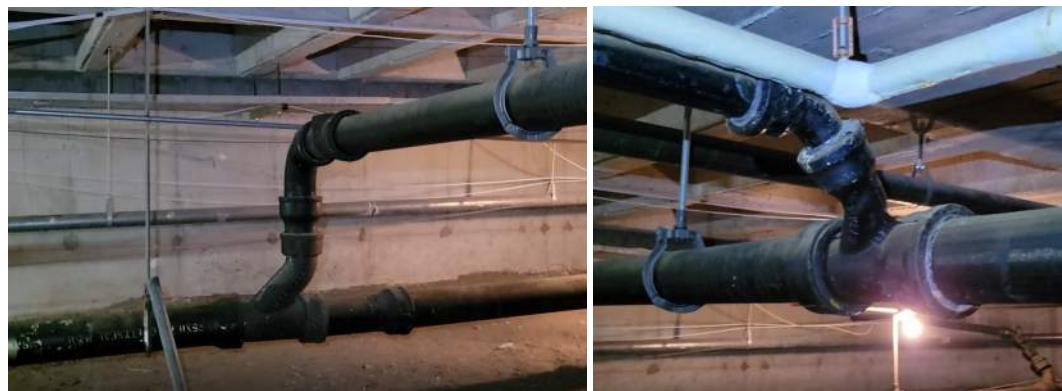
2. The sanitary service is 6" in size and leaves on the south side of the building on far west end. Original piping consists of hub and spigot cast iron for above and assumed below grade. Repairs have been made with a number of different pipe materials such as PVC, CPVC, etc. The main sanitary sewer is run above grade in the accessible crawl space. Piping to the street is called out on original documents as vitreous clay tile.

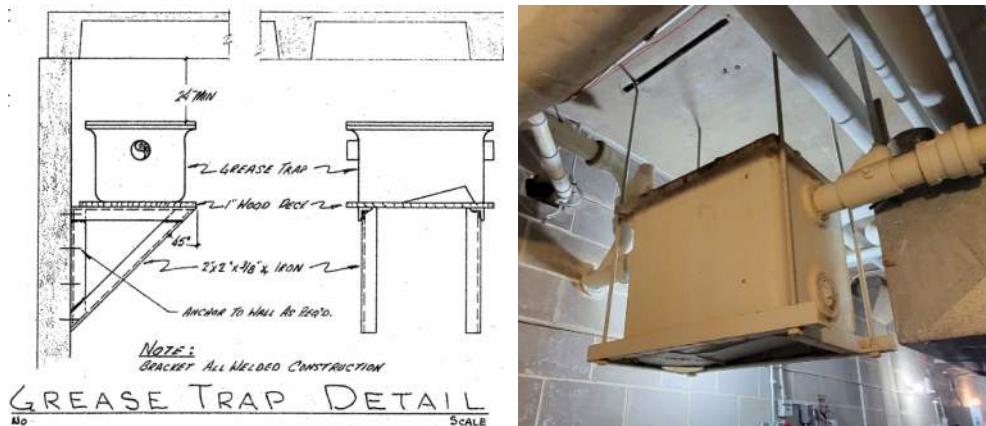
3. The existing grease interceptor (steel tank on shelf in mech room) has been abandoned per facility staff.

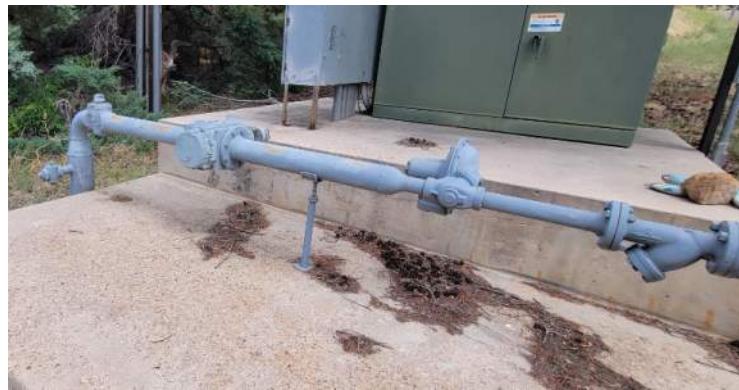
4. The VTR's on the roof are typically less than 3" in diameter per original documents.
5. Natural gas is fed from the utility gas meter on the west side of building, across the drive lane. This is a low pressure system given the 6" pipe size and no pressure regulators at each gas burning appliances.

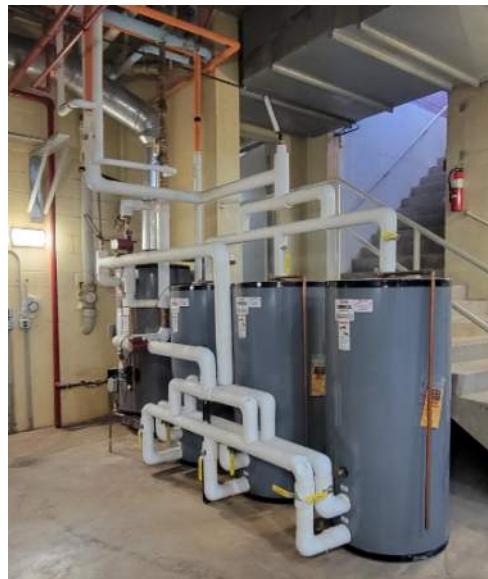
1. The domestic hot water is provided from a natural draft, gas-fired water heater located in the boiler room. It is a Rheem/Ruud, 399 MBH at 100 gallons storage with three 100 gallon storage tanks. System appears to have been installed in 2019. There is hot water circulation system.

1. The water heating system appears to be in good working order and has plenty of storage capacity.

1. Leave system as is.

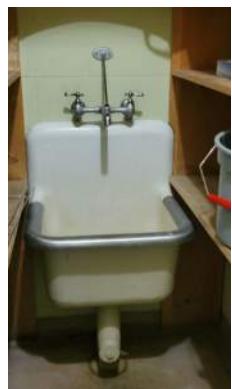
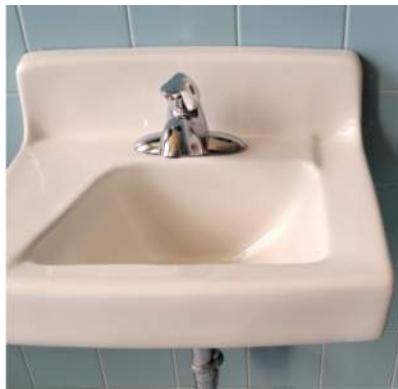
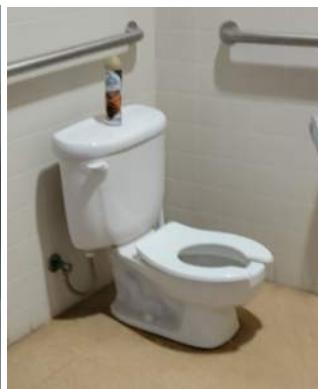
1. The toilet flushing fixtures are china type and utilize manual type flush valves with differing manufacturers through the building. Lavatories are china type, wall hung with manual type faucets of differing manufacturers and do not include point of use mixing valves. General purpose sinks are all manual style with some locations where the sink is built into the casework. Water coolers and drinking fountains are single use or high-low units, but none have water filling station. The water closets, lavatories and urinal flush valves appear to have been replaced in the 1999 mechanical upgrades.

1. The fixtures seem to be operational and are in fair condition overall, but showing signs of age and wear.

- i. All fixtures should be tested and any damaged parts should be replaced and fixtures repaired to like new condition.
- ii. All lavatories and sinks should be provided with new stops and supplies.
- iii. All lavatories should have point of use thermostatic mixing valves installed.

- i. Remove and replace all fixtures to bring up to current code flowrates and design standards.

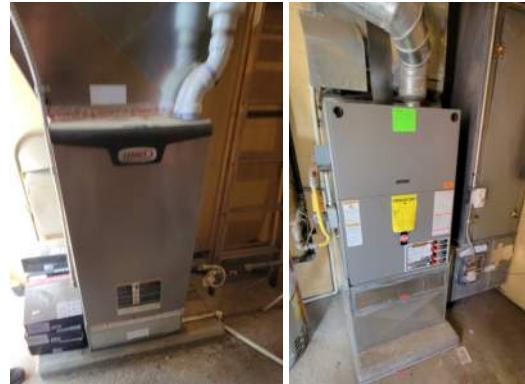
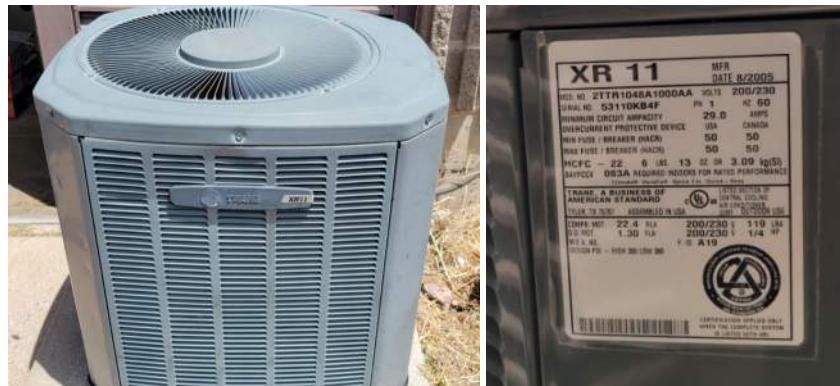
1. There are (2) indoor air handling units providing air distribution and gas-fired heating. One for the gym space and one for activity room and office. The gym duct distribution is by underground ductwork. The activity room has overhead ductwork with floor grilles for the upper level. The activity unit has DX cooling with a remote condensing unit.

1. The air distribution equipment has been replaced with residential furnaces. The gym unit was originally scheduled at 3000 cfm, but the installed unit is not capable of that airflow. The Activity unit appears to have been replaced around 2005 and is near end of useful life.
2. Existing sheet metal ductwork observed was in good condition. With professional cleaning and new sealant applied, the duct systems can be reused.
3. All the exhaust fans observed were in fair to poor condition and nearing the end of expected life.

1. Since equipment near end of life replacement of equipment is recommended. Replacement equipment shall be of commercial grade, not residential.
2. New equipment should have DX cooling. The air flow rate in the gym is short of capacity for a fully occupied load. Recommend that a second, new packaged rooftop unit (7.5 tons) be added on the new Middle School roof and back the existing gym with exposed round overhead ductwork to supplement the underground duct system.

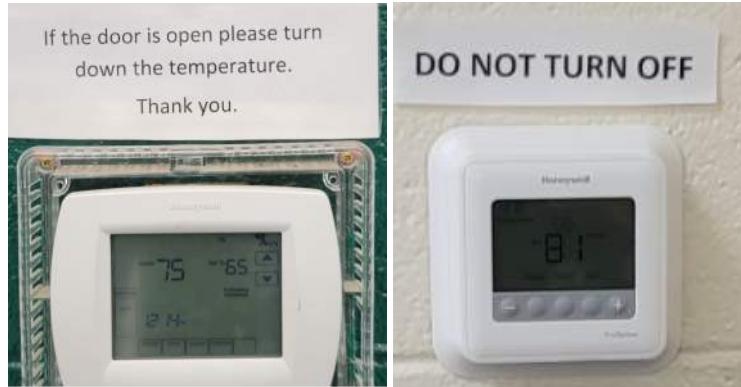
A. Existing Conditions: Each system is controlled by stand alone programmable thermostats.

1. The new replacement equipment shall be tied into new Building Automation System on the new middle school.
2. Gas-fired heating equipment in schools are required to have CO detection. Add two CO detectors.

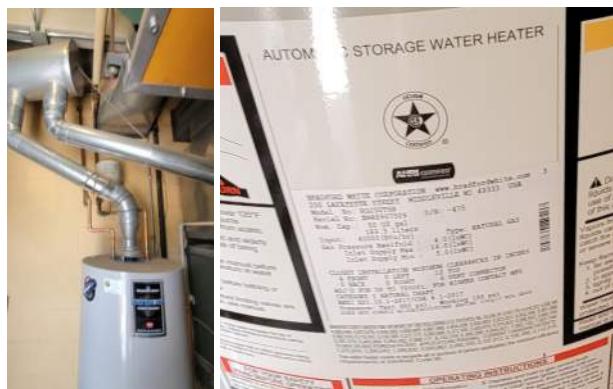
1. The building is served by a 1" water and 4" waste line.
2. Water heater is a 40 MBH, 50 gallon Bradford White, 80% efficient, which has been installed recently.

1. Piping system are original to the building, 1975.
2. Water heater is newer, but is slightly undersized for the four showers. Showers are probably not used much, so not a complaint by end users. Insulation is lacking on the water piping at the water heater.

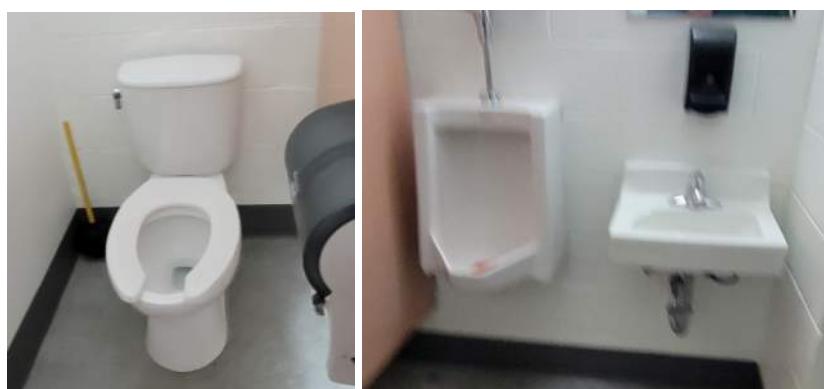
3. Fixtures are white china with flush tank toilets.

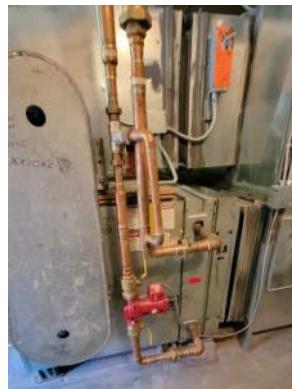
1. There is one (1) heating and ventilating McQuay air handling unit in the north mechanical room. Its air distribution system is by underground ductwork to Classroom 1 & 2 and the Reception/Lobby space, west end of building. There is no mechanical cooling. Unit appears original to the 1986 build.

1. The air handling unit is approaching 40 years old, and now beyond useful life.
2. Existing underground ductwork was not observed. Underground ductwork is a concern with IAQ with ground water penetration. More investigation needed.
3. All the exhaust fans observed were in fair condition and nearing the end of expected life.
4. Piping system lacks pipe insulation from prior renovations.

1. All mechanical equipment is past useful life and should be replaced. The new mechanical system should include mechanical cooling and mechanical ventilation to all occupied spaces for better Indoor Air Quality and thermal comfort.
2. Building has been noted to have structural issues and may be demolished. If so, obviously, a mechanical replacement would not be needed.

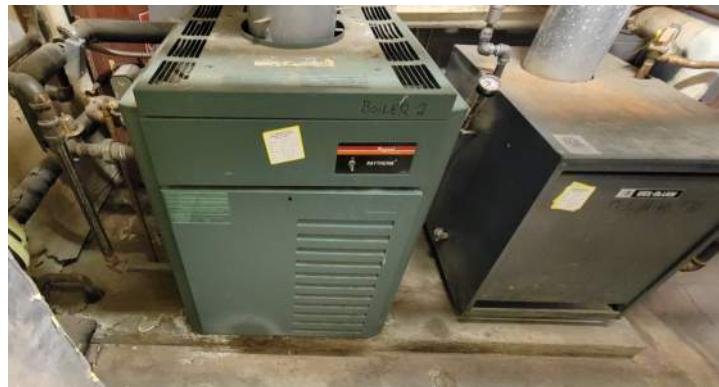
2. The remaining building (six classrooms and study spaces) are heated with only baseboard radiation heaters. Operable windows are used for natural ventilation.
3. There are two (2) gas-fired, 80% efficiency boilers that make the heating water for the entire building. One unit appears to be original to the 1986 build, the other replaced in the late 1990's. Circulation pumps appear to be original.

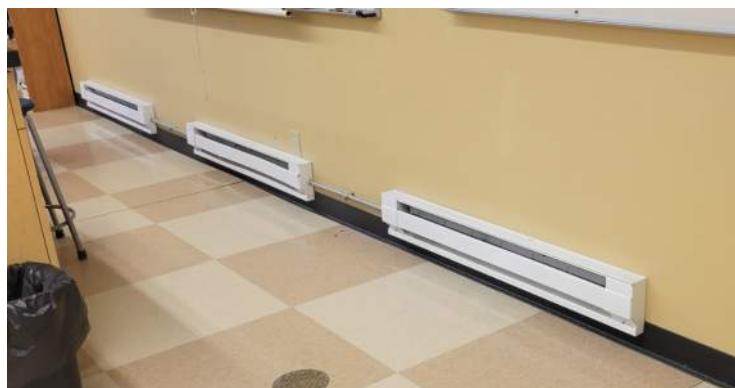
4. Electric baseboard has been added to some rooms indicated space comfort concerns from the prior design.
