STRUCTURAL CONDITION ASSESSMENT

SUMMARY REPORT

PREPARED BY: CORY MYRTLE, PE
DATE: JUNE 23, 2024

At your request, Corbel Engineering LLC performed a Structural Visual Condition Assessment Report for the Colorado Springs Charter Schools located at 2577 N Chelton Road in Colorado Springs, Colorado. The observation included three separate buildings including a middle school, elementary school and a gymnasium. The report is based upon a site visit and review of available information.

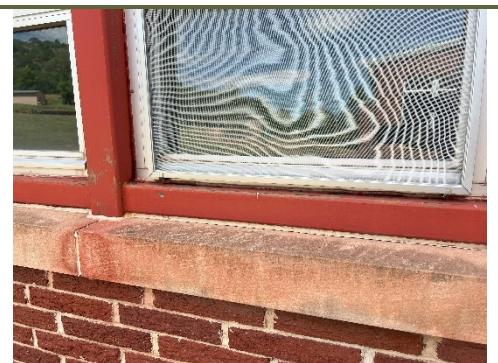
1. Failed joint sealant and caulking around windows and door openings.

Recommendation: Repair joint to protect from water intrusion and further damages.

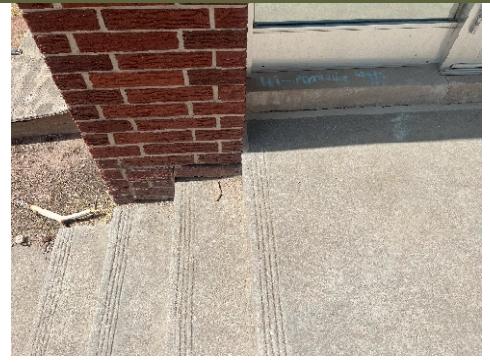
<p>2. Minor deterioration of the brick veneer around the base where exterior paving is butted against the veneer. This is likely caused by freeze thaw expansion where water is ponding against the veneer, along with the use of deicing salts.</p> <p>Recommendation: Repair and replace bricks as necessary. Seal brick to increase durability to freeze/thaw.</p>

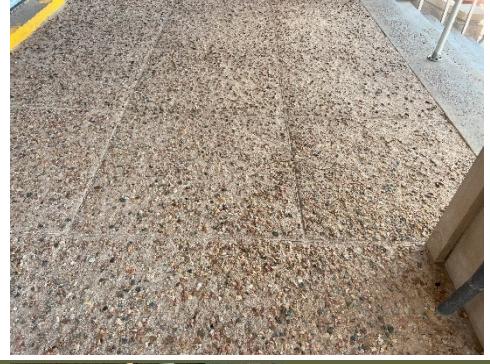
<p>3. The slab on grade at the entries has deteriorated. The likely cause is from a low-quality concrete mix design and the use of deicing salts.</p> <p>Recommendation: Replace the concrete slab on grade as necessary.</p>

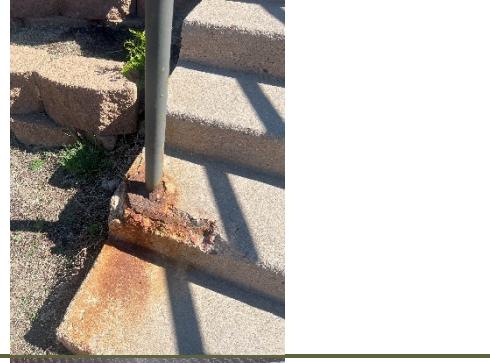
<p>4. Guardrails and handrails are showing signs of deterioration where connected to the concrete stairs along the bases.</p> <p>Recommendation: Replace deteriorated railing and repair concrete slabs.</p>

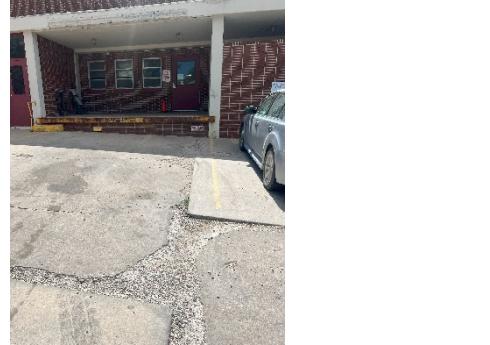
<p>5. The exterior paving around the west side loading dock is in poor condition.</p> <p>Recommendation: replace the paving and properly drain the area around the dock.</p>

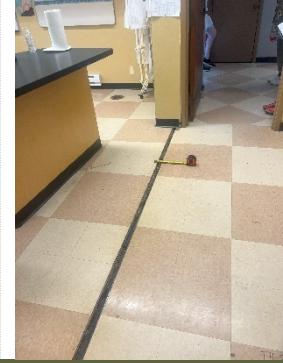
1. A large crack in the existing science classroom (northwest side) has formed between bearing wall and column. The crack appears to be caused from the settlement of the slab along the north side and heaving directly under the cracked area. This settlement and heaving caused the large crack to open up.

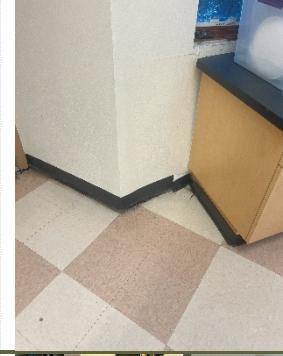
2. Settlement of the slab next to the exterior foundation grade beam is visible around nearly the entire building perimeter. Settlement of over 2" was observed.

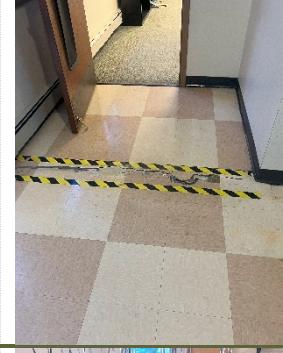
3. Large slab crack in the slab was observed in the hallway. Reviewing the existing structural drawings, this cracking is directly located over an existing foundation grade beam. This indicates that the slab has settled causing the large crack and step to form.

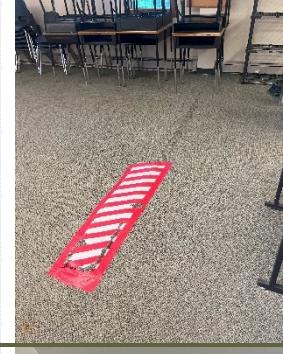
4. Slab on grade around existing foundation grade beam has settled causing a large step in the slab.

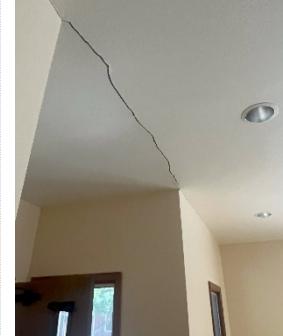
5. Large interior drywall cracks were observed along the second level of the north wing. These cracks are located next to bearing walls. No cracking on the walls was observed. It is likely these cracks are caused by some foundation differential movement. Other possible causes could be thermal expansion of the ceiling system.

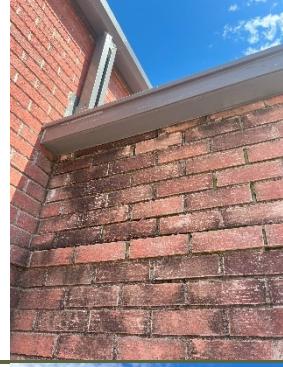
6.	<p>Deteriorated mortar jointing around gutter on the south side.</p> <p>Recommendation: Remove any loose or deteriorated mortar material and repoint the joints, sealing all cracks.</p>

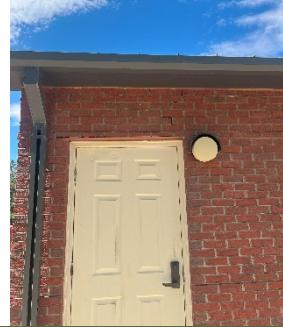
7.	<p>Cracking in the brick wall above the entry on the northeast side of the south wing was observed. Diagonal cracking in brick veneer is often caused by differential settlement of the foundation, where uneven soil movement leads to stress on the brickwork. Other possible causes include thermal expansion and contraction, which can create stress along diagonal lines, and inadequate support or anchoring of the brick veneer to the underlying structure.</p>	<p>Recommendation: Remove any loose or deteriorated mortar material and repoint the joints, sealing all cracks.</p>

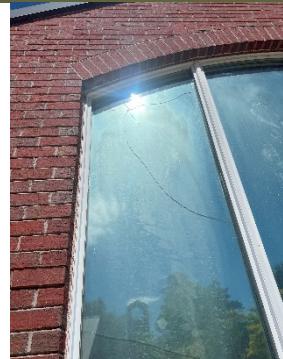
8.	<p>A window on the east side is cracked. The window frame appears to be tight to the veneer. It is our opinion that the cracking window is likely caused from some movement of the foundation system.</p>

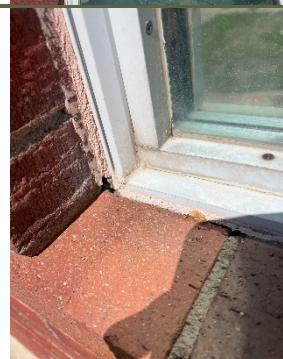
9.	<p>Failed joint sealant and caulking around windows and door openings.</p>	<p>Recommendation: Repair joint to protect from water intrusion and further damages.</p>

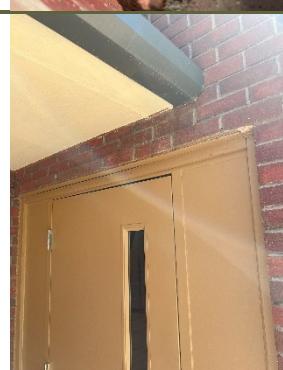
10	<p>Cracking in the brick wall above the entry on the south side of the north wing was observed. Additionally, the door frame is racked. Diagonal cracking in brick veneer and racking of door/window frames is often caused by differential settlement of the foundation.</p>

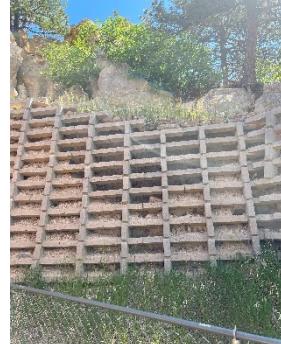
11	<p>Site retaining wall on north side of the property is washed out. This type of retaining wall depends on the soil behind for stability.</p> <p>Recommendation: Completely rebuild retaining wall.</p>

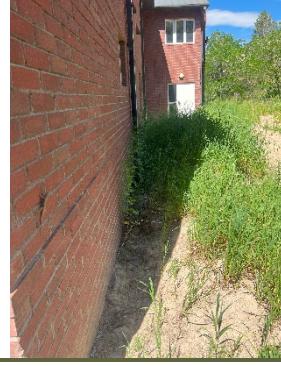
12	<p>Downspout drains water next to the building foundation. Site drainage water is ponding next to building</p> <p>Recommendation: Move downspout and re-slope grade away from the foundation.</p>
