COLORADO SPRINGS CHARTER ACADEMY ELECTRICAL ASSESSMENT

GENERAL ASSESSMENT SCOPE

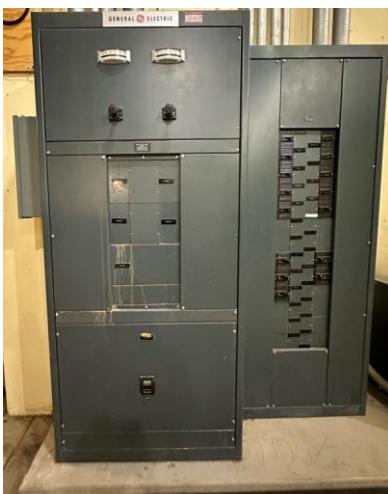
The Electrical Distribution equipment consists of a 1200 amp 480/277 volt three phase service with an 800 amp neutral. Record documents indicate the main bus in the 'M' section as 800 amps with a 600 amp neutral. The Main Distribution Switchboard is located in the basement mechanical electrical room on the west end of the building. The facility does not have centralized emergency power generation (engine-generator or battery-inverter).

Existing Main Switchboard

The distribution equipment should be replaced due to significant water damage and because it has been in service for approximately 60 years. The ability of the overcurrent devices (breakers, fused and non-fused switches) to adequately protect the feeders, circuits, equipment, and occupants, under normal operation is suspect, and under an abnormal event (fault/short circuit) is highly suspect. The safety concerns from the water damage cannot be overstated. School maintenance personnel have been told to avoid the equipment. Due to the age of the equipment and the corrosion, testing is not recommended because the testing itself could likely render the equipment inoperable. Replacement equipment, both new and original equipment parts are not readily available if at all available, and any further damage to the existing equipment would result in significant downtime. The feeder conductors serving the branch panelboards should also be replaced due to their age. It is unclear where exactly water is entering the conduits that penetrate the equipment. The original conduits are likely compromised in multiple locations and thus provide a path for water to enter the switchgear. The new switchgear should be located above grade to eliminate gravity fed flow of water in the future.

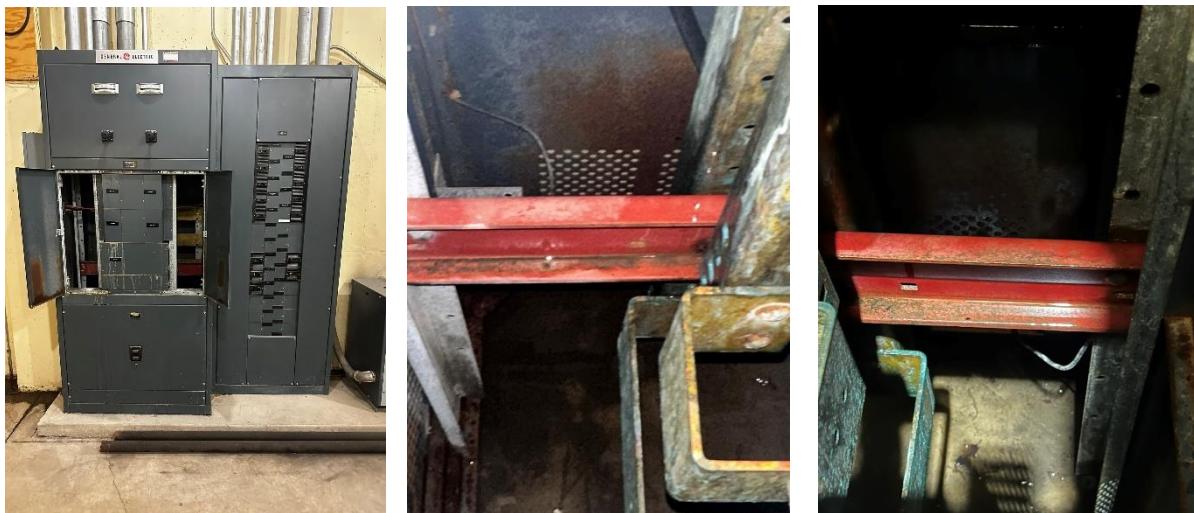
The face of the switchgear has evidence that water may have infiltrated the main switchgear. Odin Electric was able to open the switchgear on November 7, 2024. Their site visit coincided with a snowstorm and revealed water dripping inside the switchgear. The images below show corrosion of internal switchgear components and water pooling at the bottom of the base of the switchgear (left and right sides).

Water Infiltration and Subsequent Corrosion of Main Swithgear

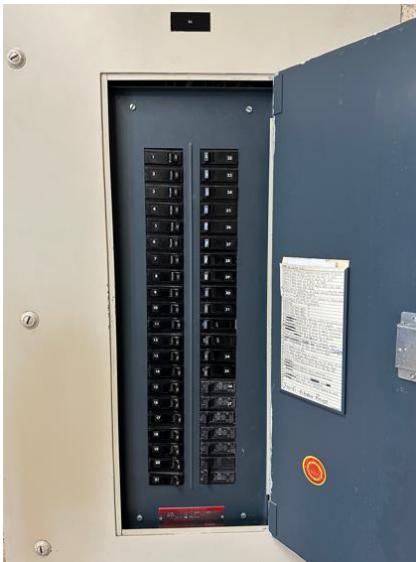
All of the school's branch circuit panelboards are original with minimal modifications. The majority of the branch panelboards are rated at 225 amps. Most of the panelboards are located in the corridors. Based on the markings of the original panelboard directories, there have been few modifications to the branch circuits in the building. Based on the equipment factory labels/nameplates the existing electrical distribution equipment are assumed to be rated at the minimum fault current levels of 10,000Amps.

Corridor recessed branch panelboard

The existing 300kVA Colorado Springs Utility (CSU) Electric Service Transformer is capable of supplying 25,800 Amps of fault current. CSU may want to install a larger service transformer which will result in higher fault current values. A full Fault-Current / Arc-Flash study would need be performed to determine the actual level of fault current available at each component of the distribution equipment. The larger service size will result in higher fault currents to the downstream branch circuit panelboards. To achieve adequate fault current capacity, most, if not all of the school's branch circuit panelboards will need to be replaced.

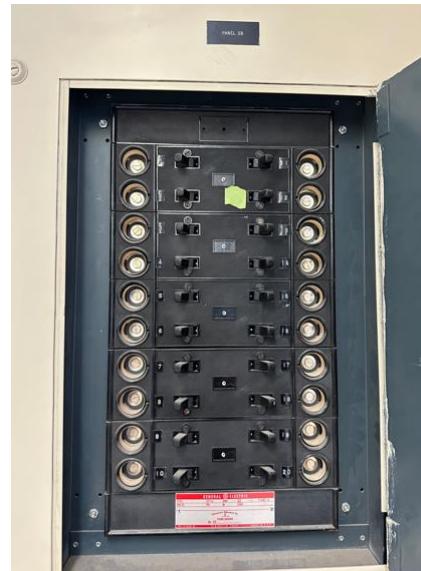
Classroom recessed branch panelboard

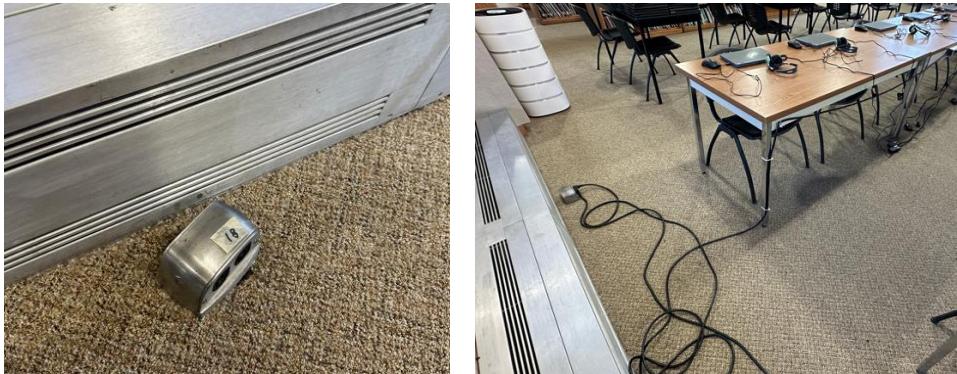
The vast majority of the existing convenience outlets are original and not tamper resistant. The quantity of outlets appears to be adequate for the school. The library was converted to a computer room and utilizes tombstone outlets due to the glass walls on the north and south sides. Some of the outlets have been removed or are loose. Cords are used to serve tabletop computers in the middle of the room. The cords present a tripping hazard. There is also an amperage draw safety concern with the number of devices served by the outlets.

Computer room tombstone receptacles

Current code requires tamper resistant receptacles for schools. The existing receptacles should be replaced with tamper-resistant type. The library (computer room) receptacles should be replaced as the tombstone outlets are old and, in some cases, loose. General convenience receptacles should be located near all large mechanical equipment located on the roof and within any utility rooms.

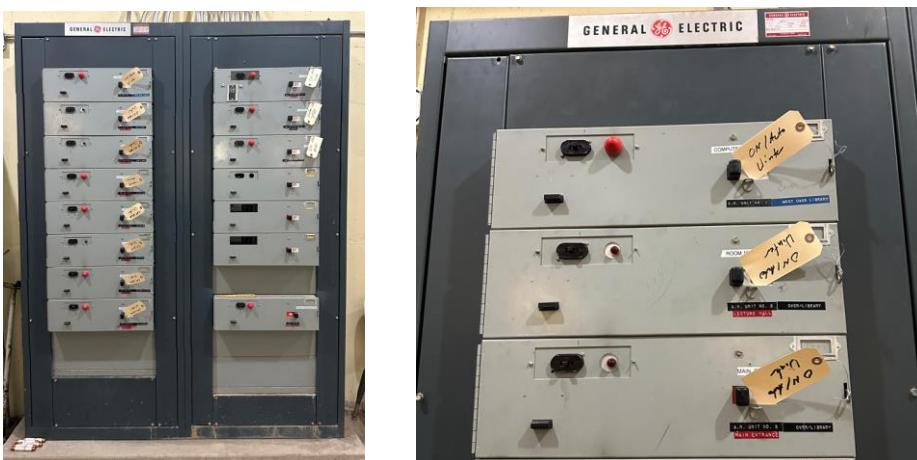
The mechanical systems are powered with the original fused disconnect motor control center. Due to the age of the equipment, it should be replaced with new fused disconnects or circuit breakers. In addition, new mechanical systems will have digital controls that will negate the need for motor starters that were part of the original electrical and mechanical systems.

Switchboard with fused disconnects for mechanical systems

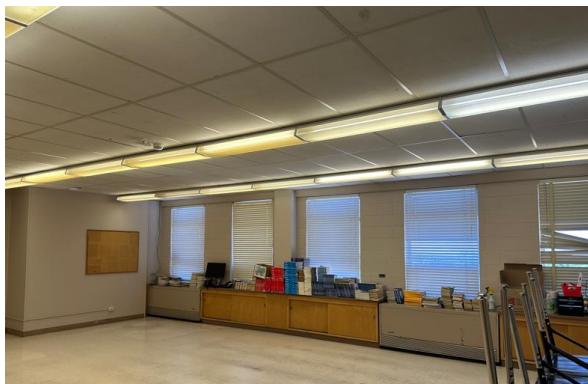
Fluorescent lighting is the primary light source used in the interior of the building. Most of the luminaires are original but they were updated with T8 lamps and electronic ballasts. The original lenses in the classroom luminaires are yellowing and brittle. The main entry lobby and the library utilize pendant luminaires. The library pendant luminaires have been retrofitted with compact fluorescent lamps and are noted to be operating on 277 volts. Several circulation areas where the light levels appeared to be insufficient. One stairwell was relying on daylighting as the existing wall mounted luminaire was missing.

Original classroom luminaires T8 lamps

Given the age of the existing luminaires, it is recommended that they be replaced with more current LED technology. The result will be a more efficient system that can also be easily dimmed to meet user preferences. In addition, the light output of the LED sources is significantly higher than previous light sources, allowing fewer luminaires than currently installed within a space or area.

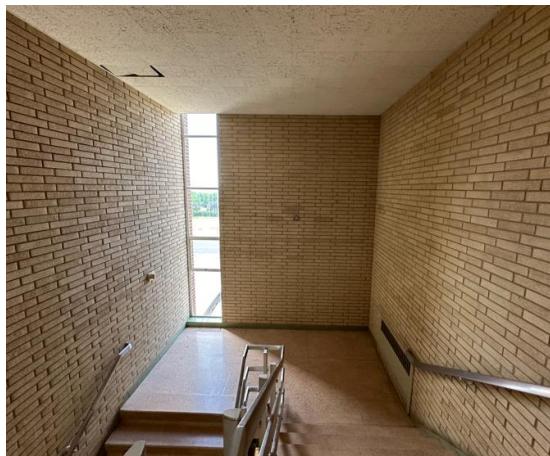
Stairwell with missing wall luminaire

The existing Exit and Egress luminaire should be thoroughly tested or replaced to ensure that the batteries are in good working order. Based on the record documents, the system of emergency egress luminaires does not meet the current code. Emergency luminaires should be added to achieve the required one footcandle egress illumination levels. The most cost-effective way of meeting the code would be to install individual wall or ceiling mounted luminaires that are equipped with an integral battery, frog-eye type luminaires. In addition, exterior emergency lights or luminaires with integral emergency batteries should be installed to meet code.

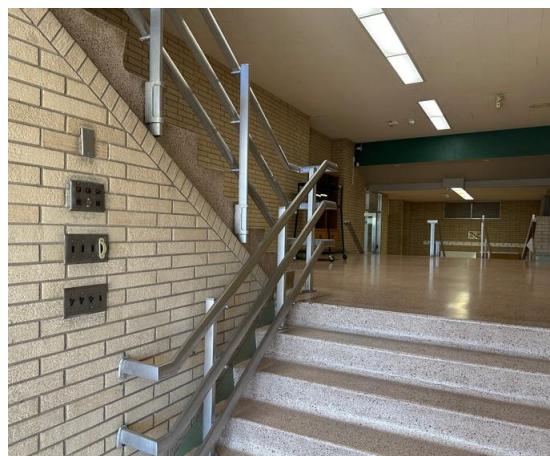
The interior lighting is controlled via local switches located throughout the facility. The original classroom lighting controls allow for the row of lighting nearest the window wall to be controlled separately for daylight harvesting. The 2008 renovated classrooms are equipped with occupancy sensors. Other areas of the school are not equipped with occupancy sensors or daylight harvesting photocells. The current energy code requires automatic off controls in the form of occupancy sensors for the interior lighting.

Original Corridor luminaires with original switching

The new LED lighting system would need to comply with the State's adopted 2021 International Energy Conservation Code (IECC). The code will require occupancy sensors or timeclock controls to meet automatic off requirements for both the interior and exterior areas. The lighting controls for most areas would also have dimming capability to meet the current energy code. The new lighting systems should be designed using the Illumination Engineering Society (IES) guidelines for illumination levels depending upon space function. Flat panel type LED luminaires are an economic choice for providing quality LED lighting for interior school environments. Exterior LED luminaires would also be required to meet the current energy code. Due to the exterior entry canopy construction, the new exterior LED luminaires may need to be surface mounted to simplify installation. For better safety, new pole mounted LED luminaires are recommended at the main entry pick-up and drop off area.

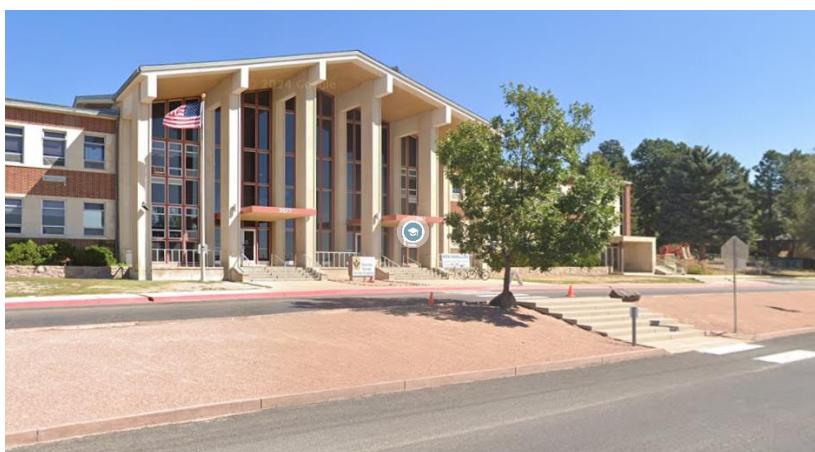
No pole lighting at main entry drive

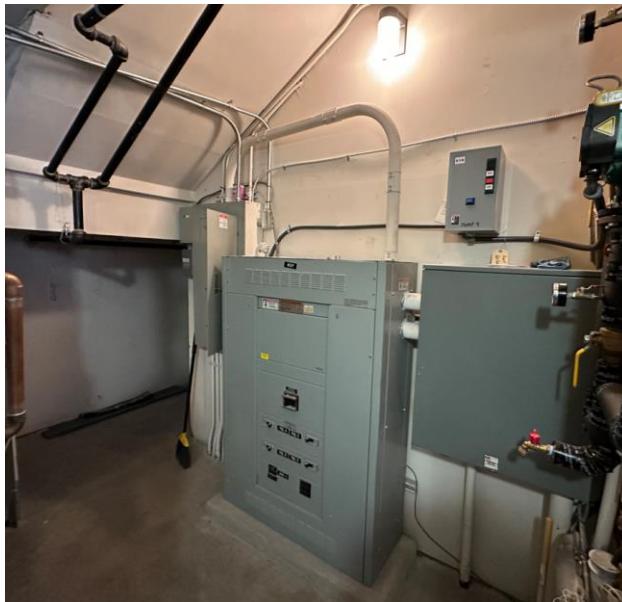
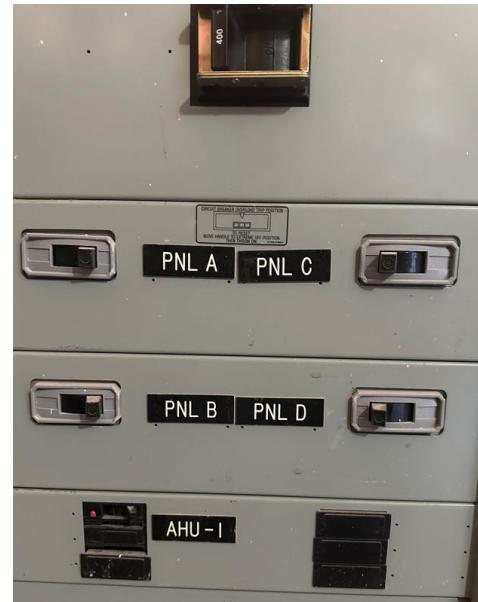
Main Distribution Panel in Mechanical/Electrical Room

The electrical distribution equipment is in good condition and there is spare capacity in the branch circuit panelboards. While not nearly as critical as the elementary school, the main distribution panel and the branch circuit panelboards are 38 years old and should be replaced. The feeder conductors serving the branch panelboards should also be replaced due to their age.

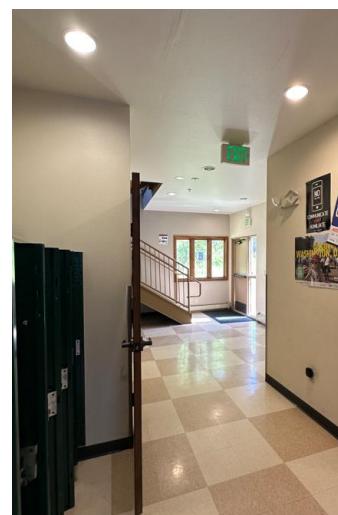
The classroom lighting is controlled via local switches. The corridor lighting does not have local switching but is controlled with ceiling mounted occupancy sensors. The facility manager indicated that they need to replace the compact fluorescent lamps in the downlights at an unusually high rate.

Corridor fluorescent downlights

The existing fluorescent lighting is 14 years old and therefore not a critical item that needs to be replaced. New LED lighting would, however, provide energy savings for the school and allow for the lighting to be dimmed. Given that all of the ceilings are inaccessible, wireless lighting controls would be a good option if they were to be replaced. Given the age of the existing exterior luminaires, it is recommended that they be replaced with more current LED technology. The pole light heads should be replaced with full cut-off rated LED pole heads to meet the Colorado Springs standards. The new exterior LED lighting system would need to comply with the State's adopted 2021 International Energy Conservation Code (IECC). This code requires that the lighting be dimmed or turned off after hours. Exterior emergency lights or luminaires with integral emergency batteries should be installed to meet code.

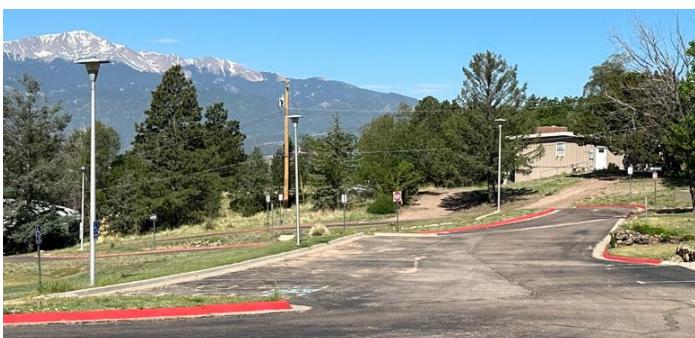
The exterior of the building has recessed lensed luminaires, wall mounted luminaires and bollards. There are some pole luminaires that illuminate the parking area and entry drive. These pole lights do not meet the Colorado Springs lighting standards as they are not full cut-off rate. The exterior lighting is controlled by a timeclock. According to the record drawings and the site survey, none of the exterior lighting was replaced in 2010.

Not full cut-off pole mounted luminaires at parking lot

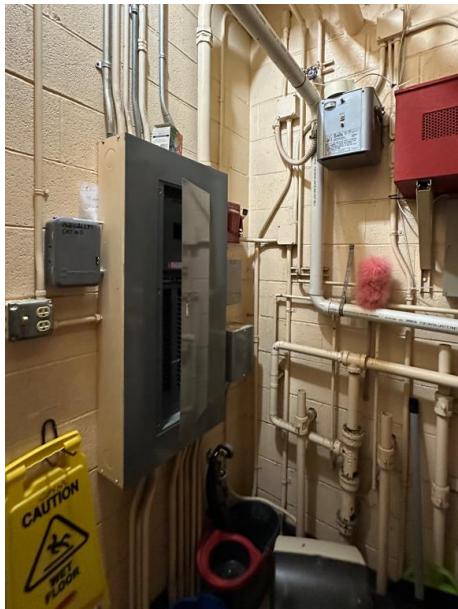
Main electrical panel in janitor's closet

The generally accepted life of electrical service distribution equipment is 30 years. Given that the existing equipment is nearly 49 years old it should be replaced. Any new Distribution Panelboard and Branch Circuit Panelboards shall be full size commercial electrical branch circuit panelboards with fully rated phase and neutral copper bussing and bolt on breakers mounted in NEMA 1 enclosures with a Door-in-Door panel cover. The branch breakers will be molded-case type with mechanical lugs. The new electrical distribution equipment can be specified to match the existing distribution equipment, or be specified to be provided by one of the manufacturers listed below:

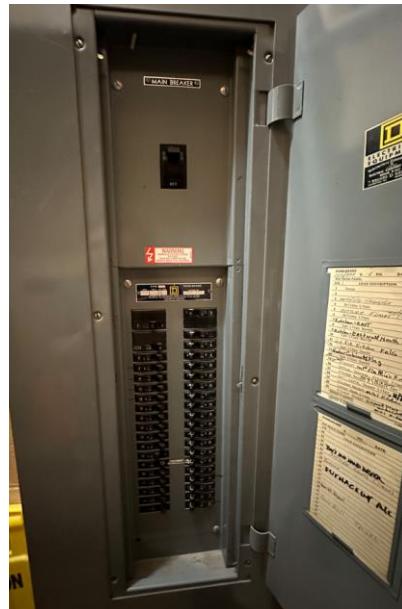
Main electrical panel

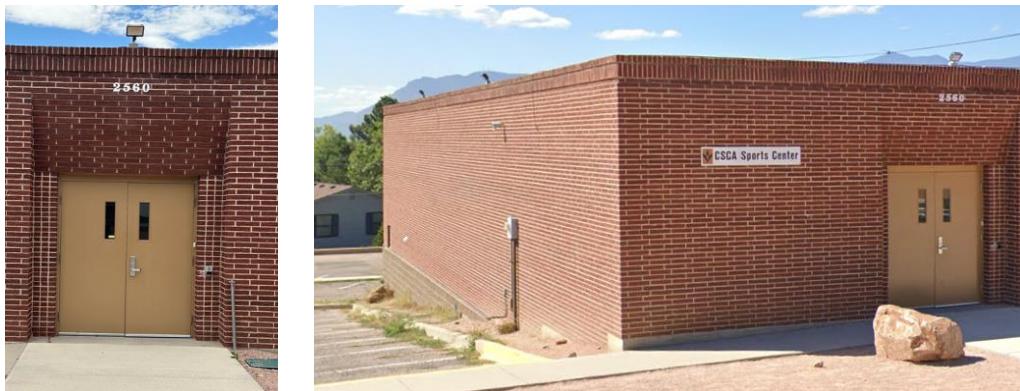
LED floodlights illuminate the exterior perimeter of the building. The angle of these flood lights is not ideal as it is a source of glare for visitors and the surrounding neighborhood. To meet the Colorado Springs exterior lighting ordinance, the lights should be aimed straight down but this would limit the lighting coverage for the parking and pedestrian areas. For better safety and security, pole lighting would provide better illumination and is recommended for the parking areas. This would allow for the building mounted lighting to be full cut-off rated to meet the Colorado Springs standards. Any new exterior LED lighting system would need to comply with the State's adopted 2021 International Energy Conservation Code (IECC). This code requires that the lighting be dimmed or turned off after hours. Exterior emergency lights or luminaires with integral emergency batteries should be installed to meet code.

Roof Mounted LED flood lights
