**Limited Asbestos Inspection
Colorado Springs Charter School
2577 North Chelton Road
Colorado Springs, Colorado**

WALSH Project Number: 6491-010
September 1, 2009

EXECUTIVE SUMMARY

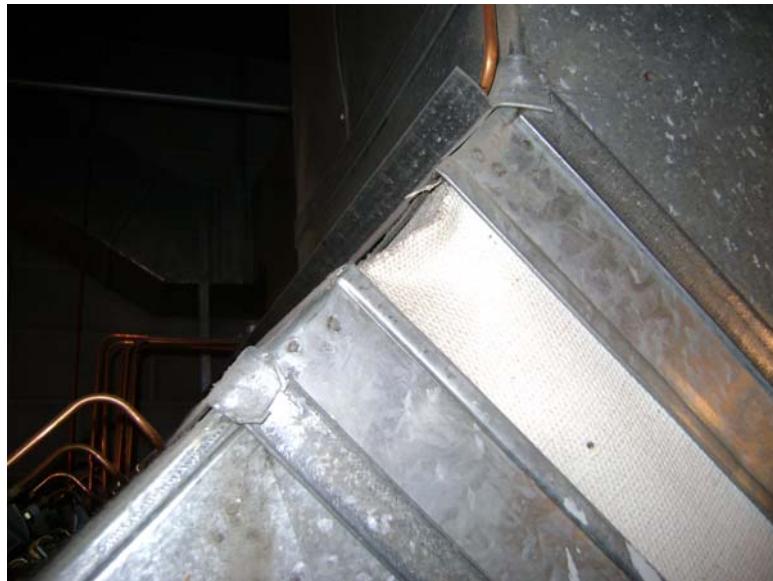
The vibration dampener expansion gaskets were found to contain 45% Chrysotile asbestos. This material is considered nonfriable and located in the mechanical rooms on HVAC ducting.

**2577-EG01: Vibration Dampener Expansion Gasket.**

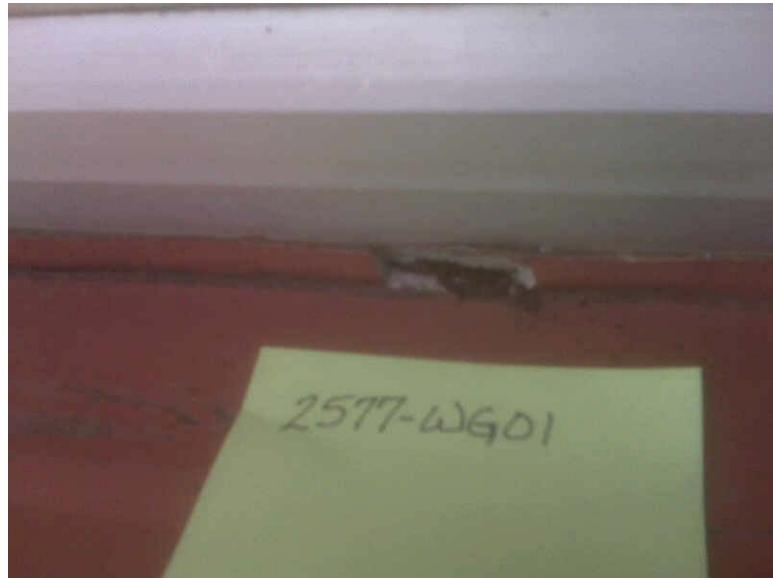
The window glazing was found to contain 2% Chrysotile asbestos. This material is considered nonfriable around exterior windows.

**2577-WG01: Grey Window Glazing**

Comments: GLAZING HAS WEATHER CRACKS
