Date: **July 1, 2024**
Re: Civil Site Assessment
Project Location: 2555/2577 N Chelton Road, Colorado Springs, CO

CSCA Civil Site Assessment Summary Report

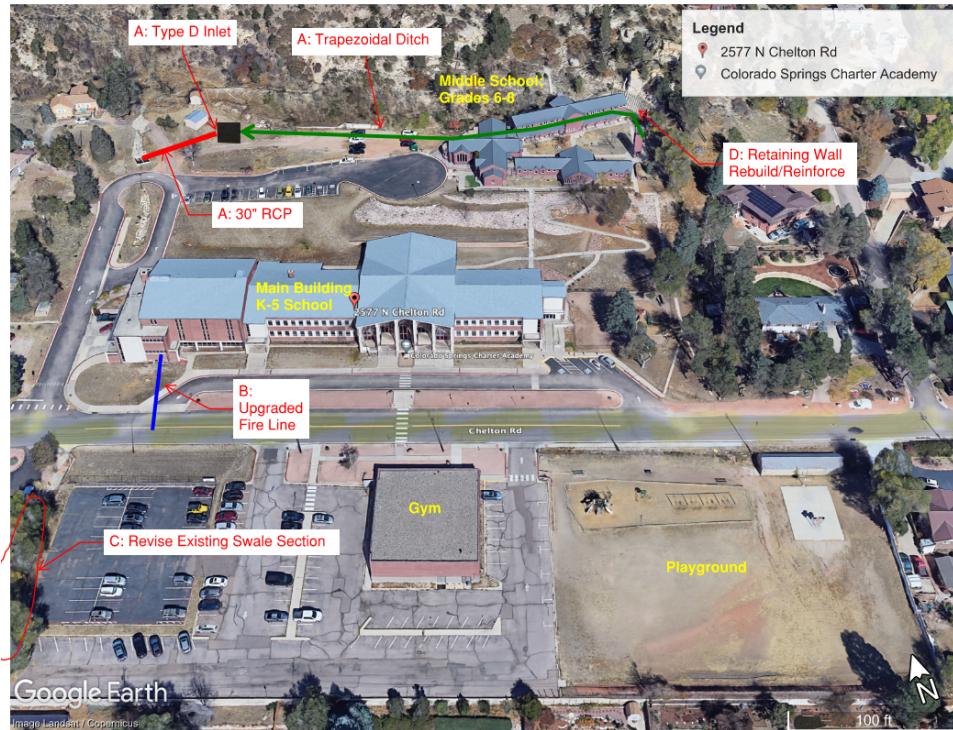
Image 1: Civil Assessment Mitigation Visual Summary

Raptor proposes the following recommendations. Please note that these recommendations are conceptual in nature and require additional analysis and City approval to verify full design. Additional capacity and detailed analysis is required to confirm recommendations. Refer to Images 1 and 2 below for a visual summary.

- A new drainage swale and inlet will be required to convey the mountain flows around the MS. Preliminary drainage analysis identifies over 3.5 acres of mountain face which produces an estimated peak of ~28 cfs in the 100-yr storm event. A trapezoidal concrete swale that's approximately 5' wide at its base, 4:1 slope, and 2 feet deep will be required to route flows west away from the school. A new 6'x4' Type D (parallel & depressed) inlet will be required to capture flows. ~50 lf 30" RCP pipe will be required tie flows into the existing storm system to the west.

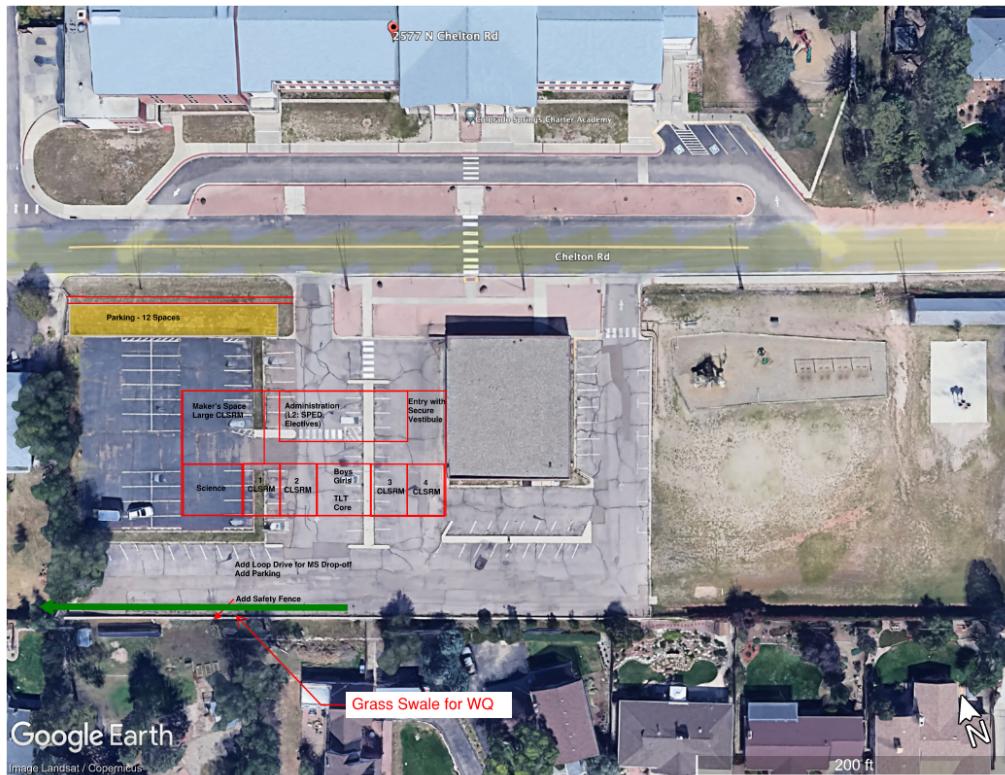
Image 2: Relocation of MS Stormwater mitigation

- A new drainage swale and inlet will be required to convey the mountain flows around the MS. Preliminary drainage analysis identifies over 3.5 acres of mountain face which produces an estimated peak of ~28 cfs in the 100-yr storm event. A trapezoidal concrete swale that's approximately 5' wide at its base, 4:1 slope, and 2 feet deep will be required to route flows west away from the school. A new 6'x4' Type D (parallel & depressed) inlet will be required to capture flows. ~50 lf 30" RCP pipe will be required tie flows into the existing storm system to the west. A water quality feature, likely a grass swale, will be required to treat stormwater runoff from the new building. If area of improvement is < 1 acre, no onsite detention is required.

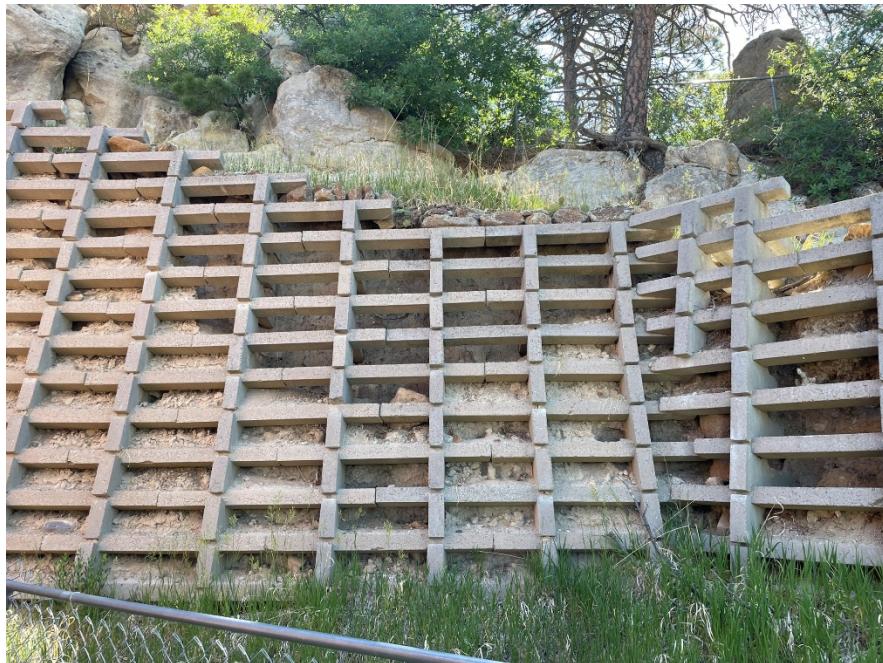
Image 3: Existing Retaining Wall

- The existing retaining wall will require rebuild or reinforcement to increase integrity. A concrete diversion channel to be located uphill to reduce flows over wall.

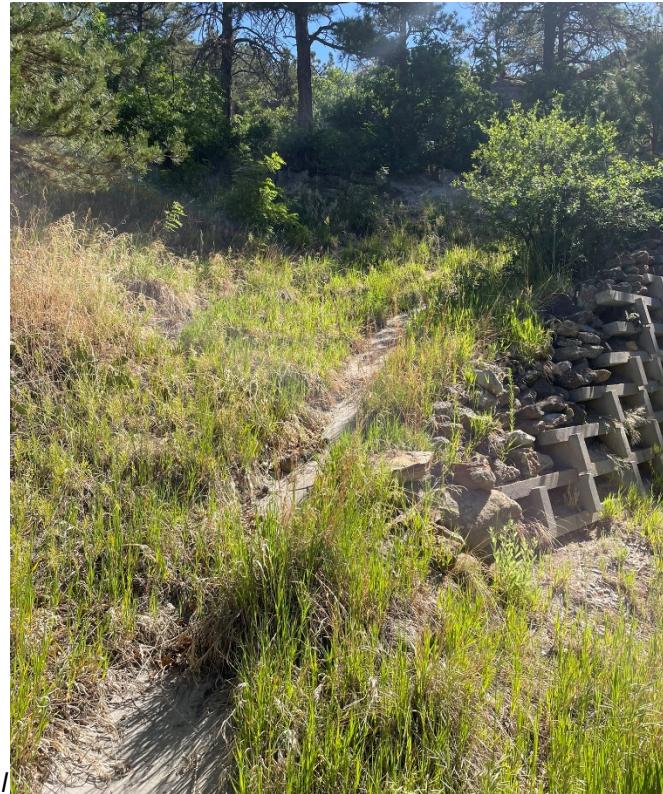
Image 4: Existing Retaining wall concrete rundown

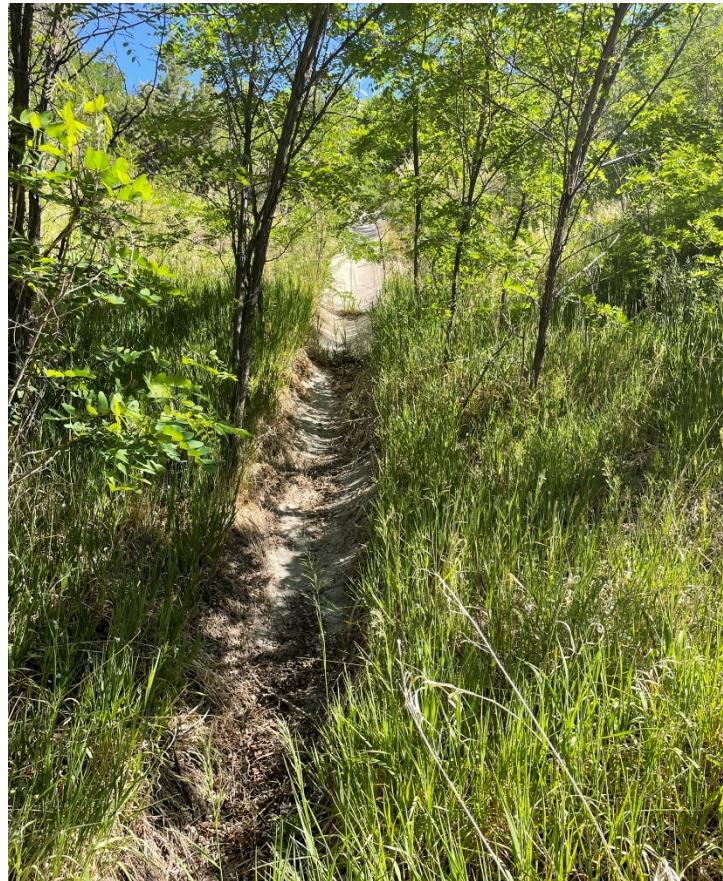
Raptor reviewed existing Development Plans for the site and reviewed the existing drainage mitigation systems onsite. A concrete channel existing that's routes concentrated mountain runoff towards the rear of the MS to a 6" area drain between the MS and mountain base. The 6" drain outfalls into the grassed courtyard between the MS and Elementary school and is routed to a drainage swale that routes flow south under Chelton Rd and into a ditch that continues south offsite. The surrounding mountain runoff sheet flows to the base of the mountain. A manmade berm is intended to direct flows west away from the MS or towards the area drain. A large stormwater inlet exists in the NE portion of the lot is intended to capture a portion of the maintain runoff and direct towards the existing ditch that runs south.

Image 5: Existing Concrete Pan within Mountain

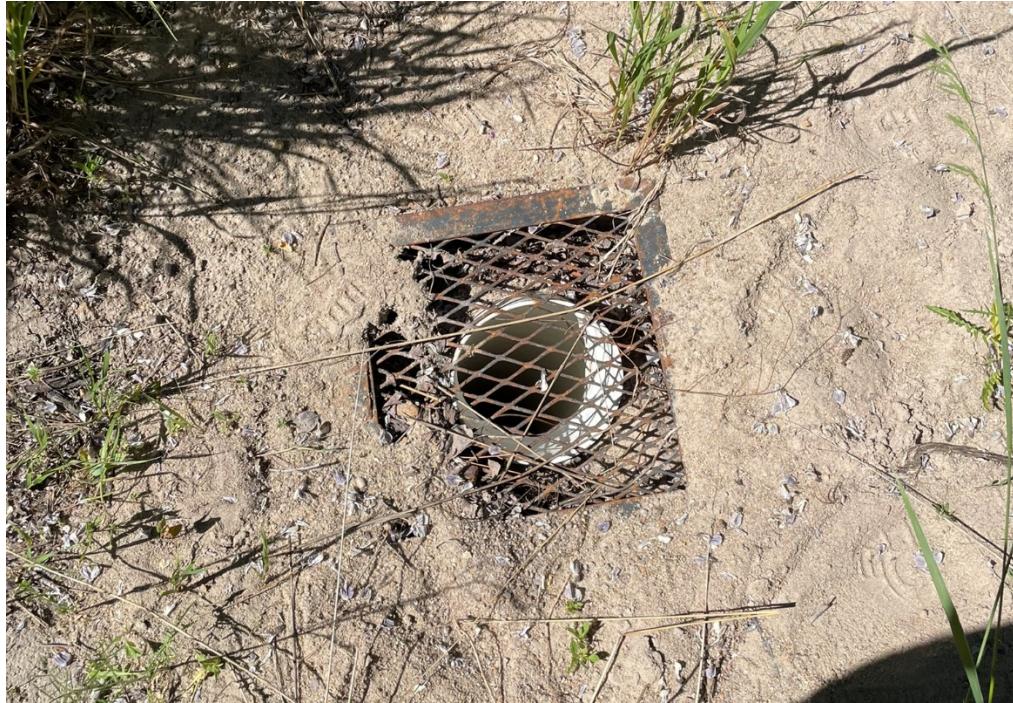
- The existing ditch system running south of N Chelton Rd has a swale section that inadequately conveys the volume of runoff directed to it which is causing erosion of the landscaping area adjacent to the existing house.
- The existing 6" drainage pipe and area drain lack the capacity to adequately capture and convey the 3+ acres of mountain runoff. And the surrounding "swales" lack the capacity to adequately convey flows around the school and/or to the existing area drain.
- The existing retaining wall in the NE corner of the existing MS is degrading and due to its proximity to the MS, poses safety concerns due to its increasing instability.
- The existing line to the building from N Chelton road may require upgrade in size from 4" which is likely undersized for future demand needs.

Image 6: Existing 6" area drain behind MS rear at base of concrete pan

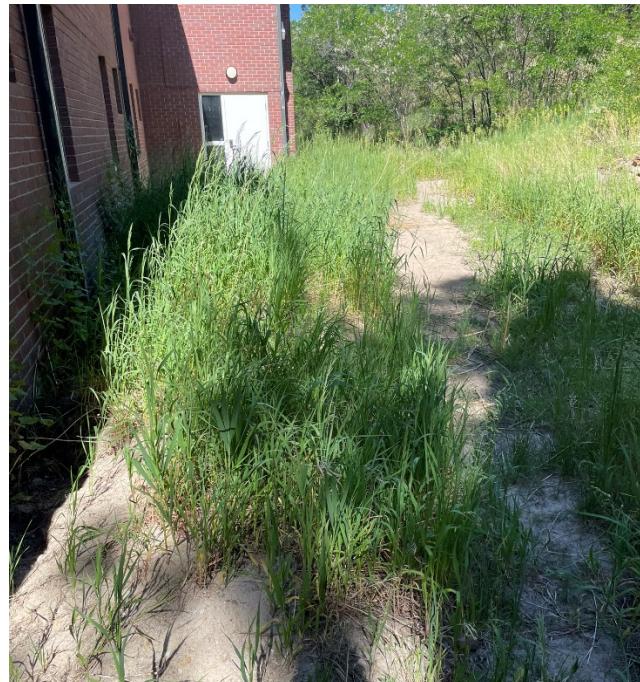
In the existing condition, the MS abuts to the base of a mountain range that currently directs over 3-acres of runoff towards the MS. Raptor understands that during rainfall, runoff from the maintain is directed directly towards the MS and has caused flooding of multiple feet in depth which resulted in damage to the school interior/exterior as a result. Videos were viewed from the Charter School showing the extent of flooding that occurs around the MS during heavy rainfall. The MS contains multiple locations of sandbags and manmade berms to attempt to redirect runoff.

Image 7: Existing manmade berthing adjacent to MS at base of mountain

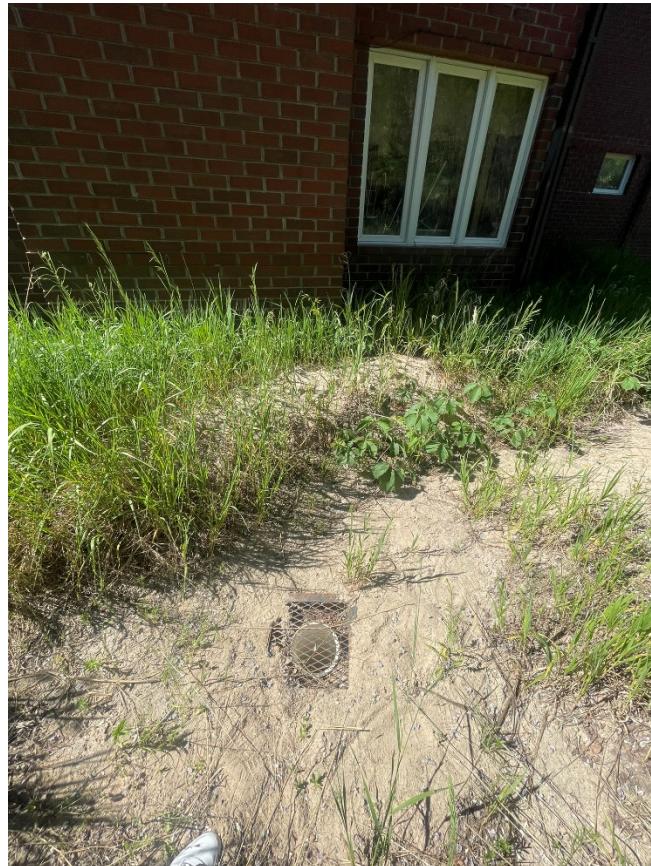
Image 8: Existing manmade berthing adjacent to MS at base of mountain and area drain

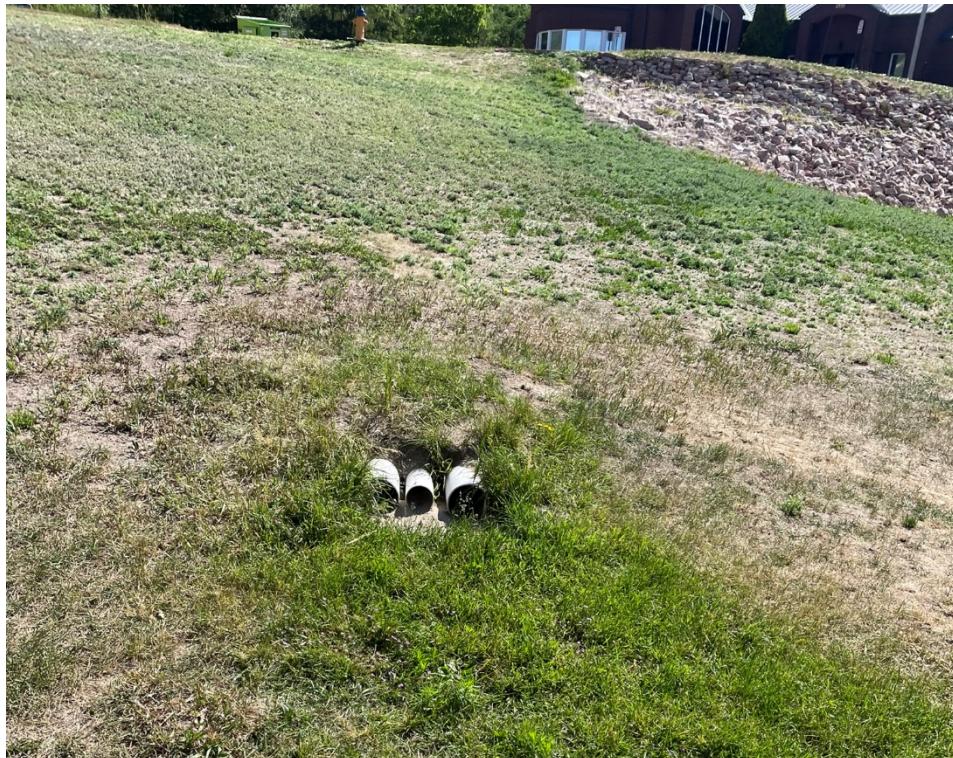
Image 9: 6" Area drain outlet

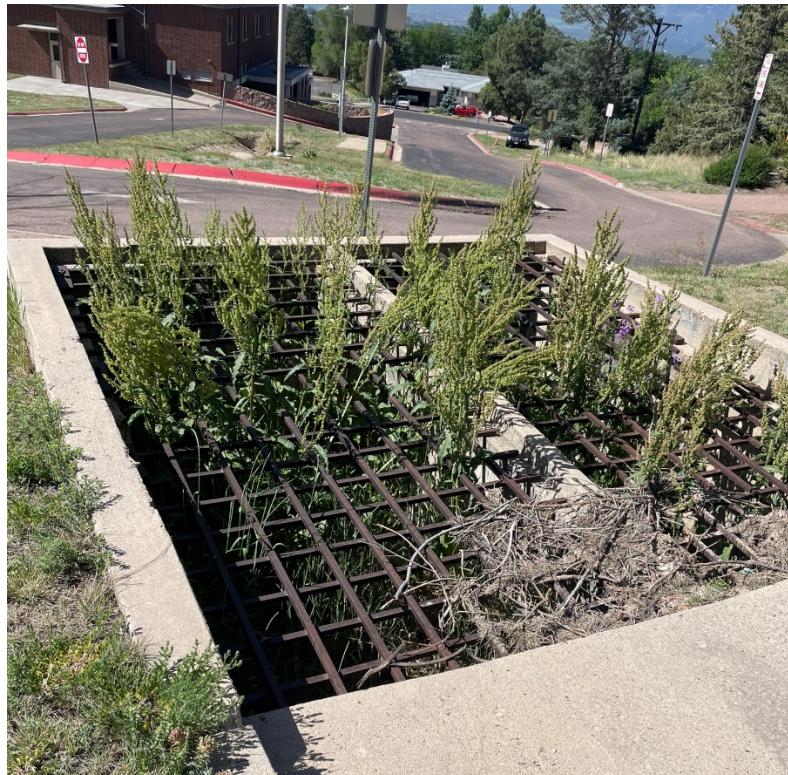
Image 10: Existing stormwater inlet

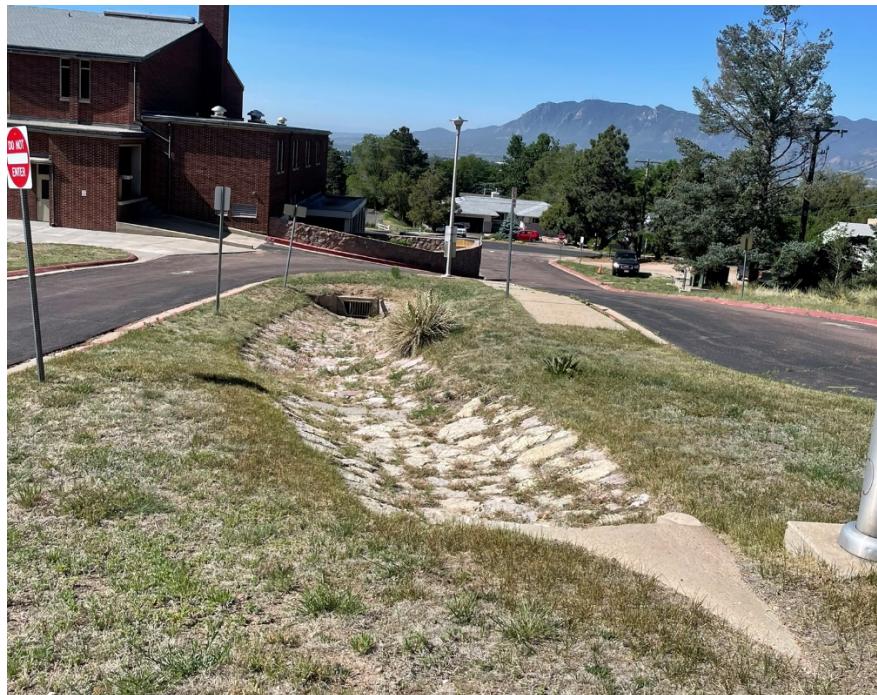
Image 11: Existing Storm ditch downstream of inlet

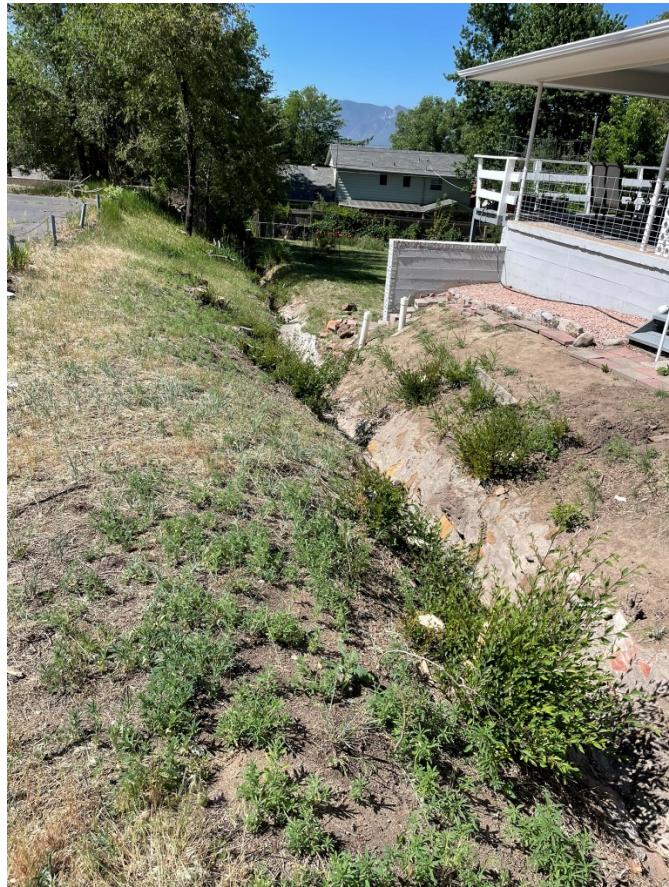
Image 12: Existing Ditch where flooding causing erosion to adjacent residence

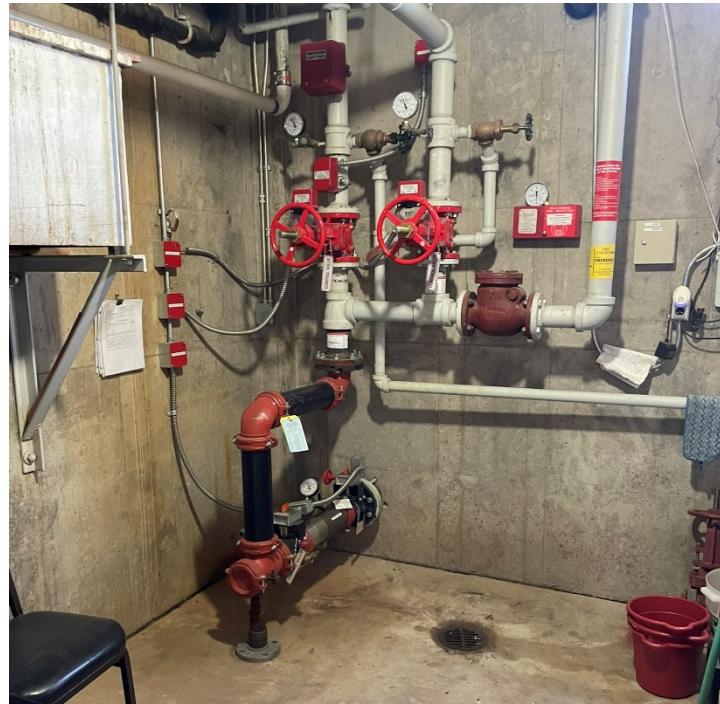
The Elementary School, within its basement, has a fire system that services the basement. Per the 1966 Sprinkler Plans, the service line from N Chelton Road is 4".

Image 10: Existing Fire Riser Room in the Elementary School basement

- The existing line to the building from N Chelton road may require upgrade in size from 4" to 6"-8" based on demand need.
- The existing drainage swale along western parking lot will require widening to match the surrounding uphill concrete ditch section.
