Colorado Springs Charter Academy

**K-8 HVAC, Electrical, Fire Systems Replacement
Storm Drainage & MS Replacement
Security Upgrades**

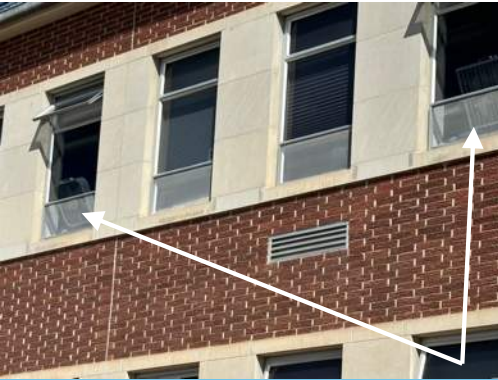
Window fans supplement inadequate ventilation.

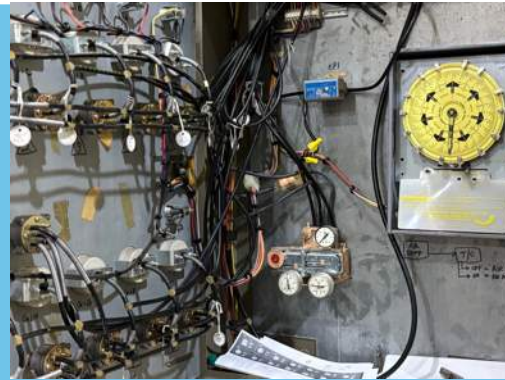
1966 vintage controls are failing and cannot be serviced.

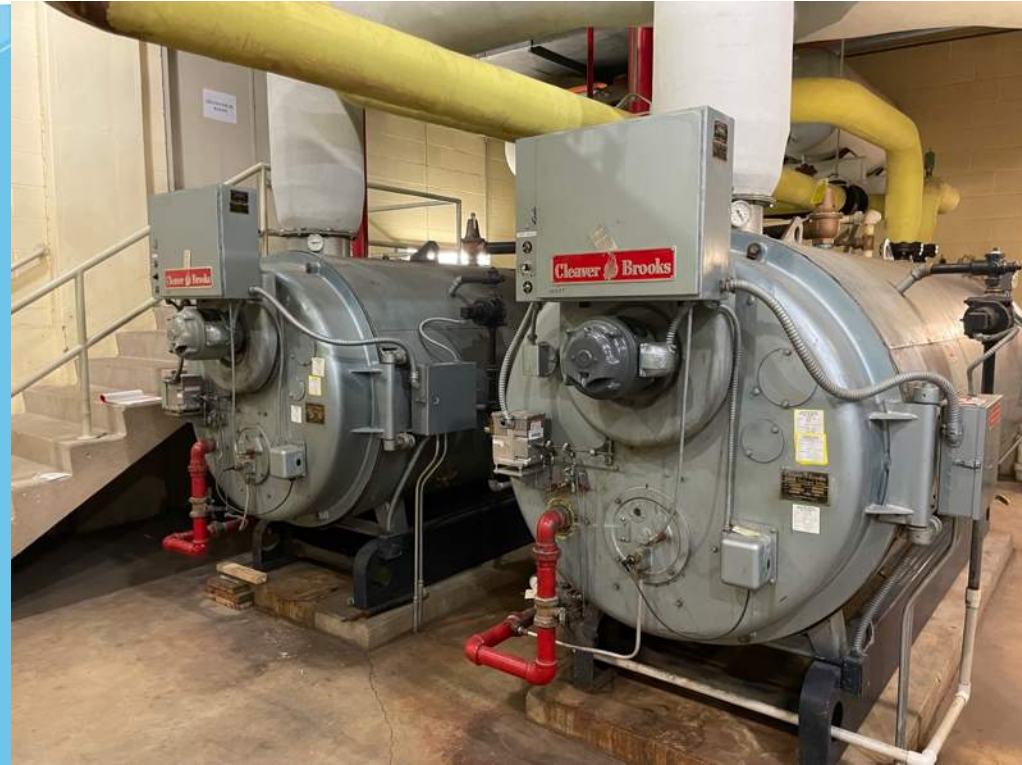
1966 Boilers have been repaired extensively and have far exceeded their useful life.

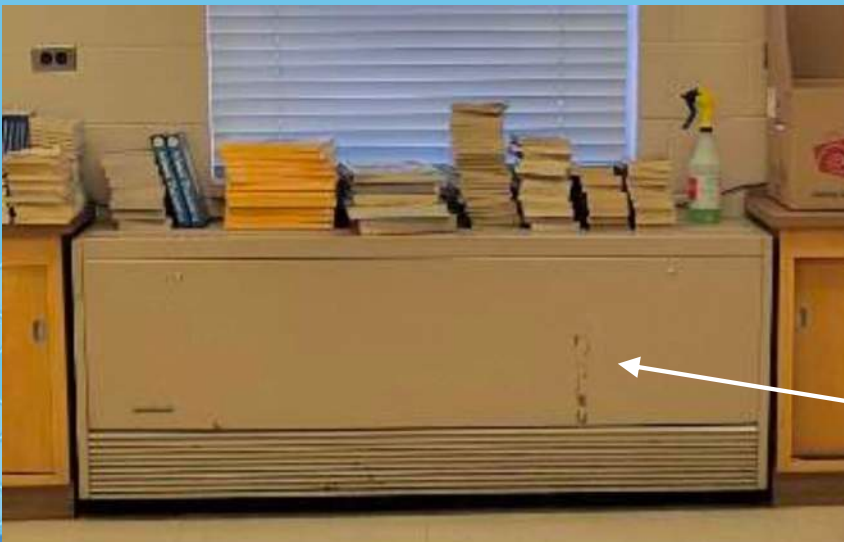
1966 Unit Ventilators serving classrooms are inadequate for current ventilation requirements and have far exceeded their useful life.

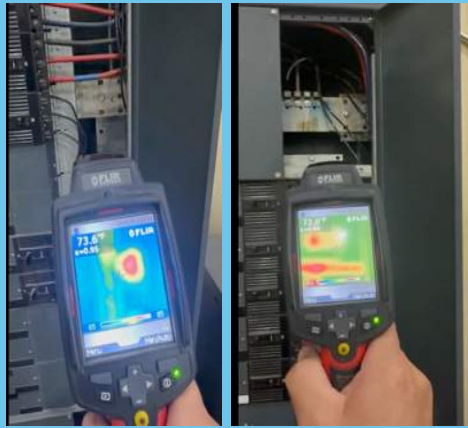
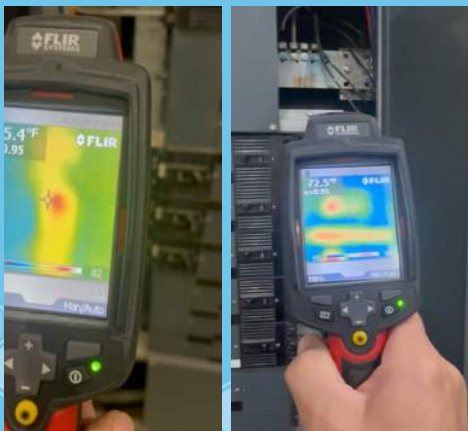
Corrosion and Water Intrusion at Main Gear Creates Emergency Condition

Thermal imaging (red) shows imminent breaker and buss failure at all locations

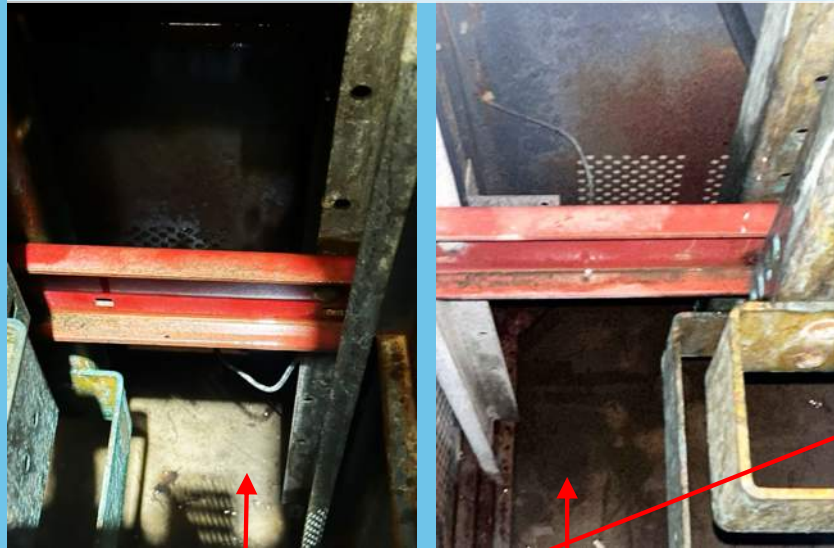
Electrical Service is 60 years old and has far exceeded its useful life

Water actively dripping inside main gear and 1" standing water pooling at bottom of panel has corroded internal components.

Emergency Repair is scheduled for Summer 2025

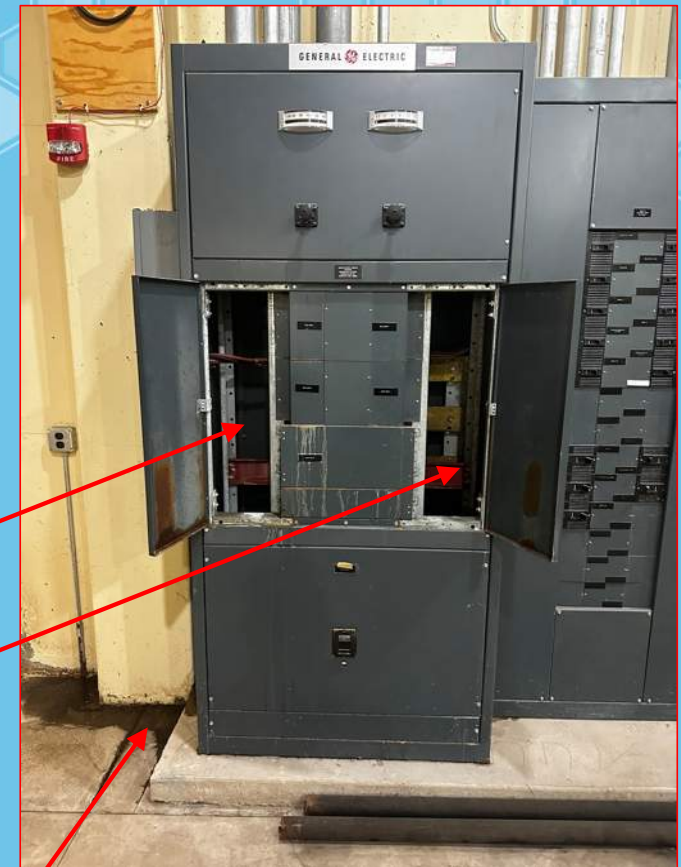
Water intrusion at Main Electrical Gear creates an **extremely dangerous** condition and has corroded Main Gear

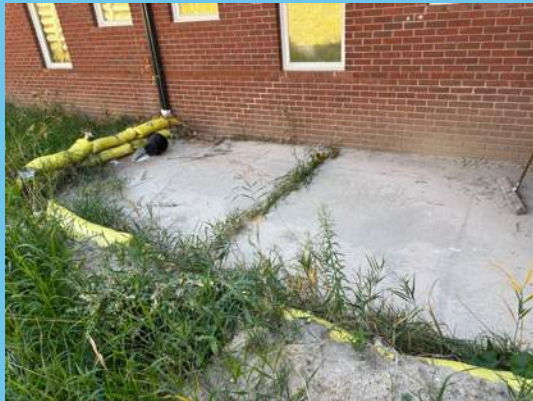
Sandbags fail to protect Middle School from reoccurring flooding.

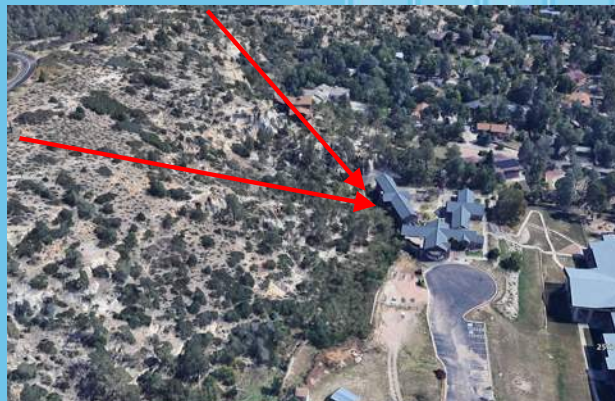
Steep rocky "V" slope conveys storm water directly to Middle School; Landslide risk

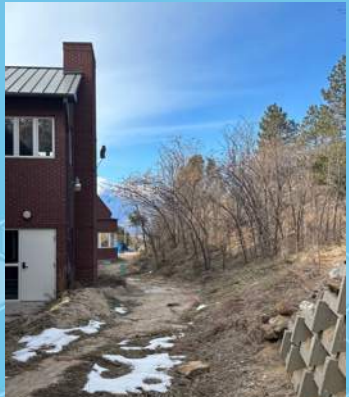
Narrow space between MS and steep rocky incline (6-10 feet) is inadequate to install Drainage Solution.

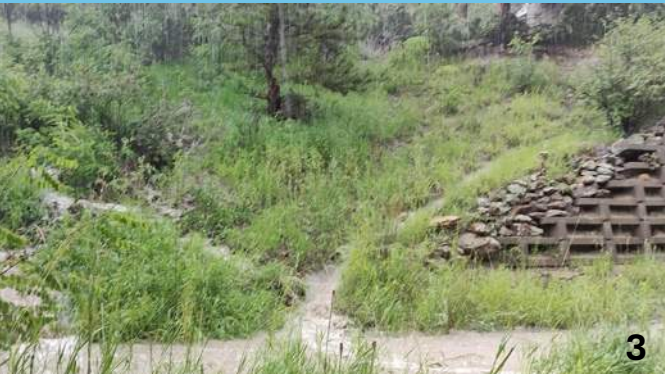
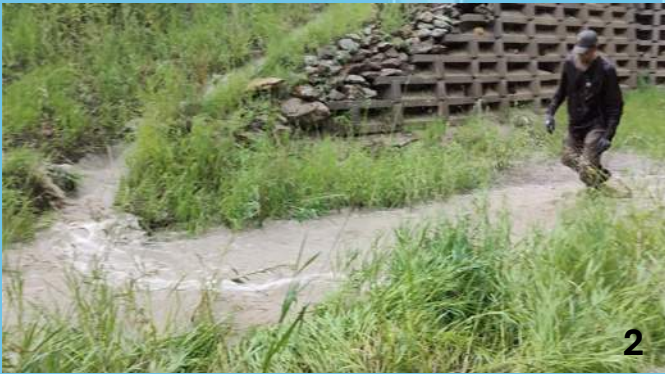
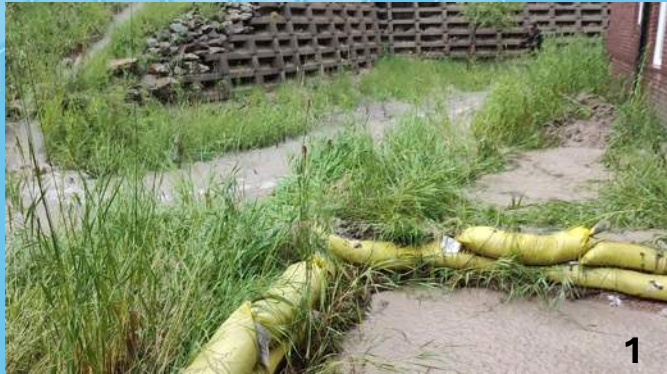
Torrential Storm Flows directly impact Middle School causing flooding and structural distress

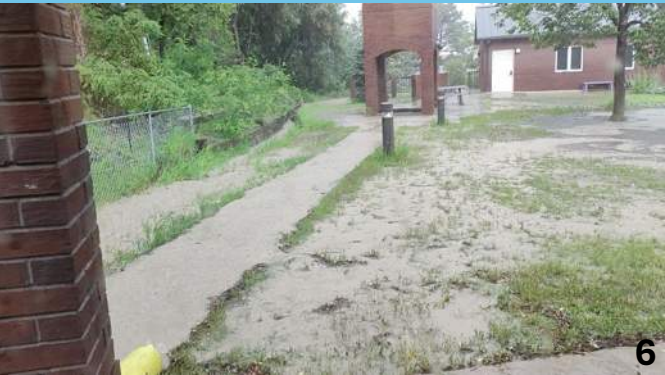
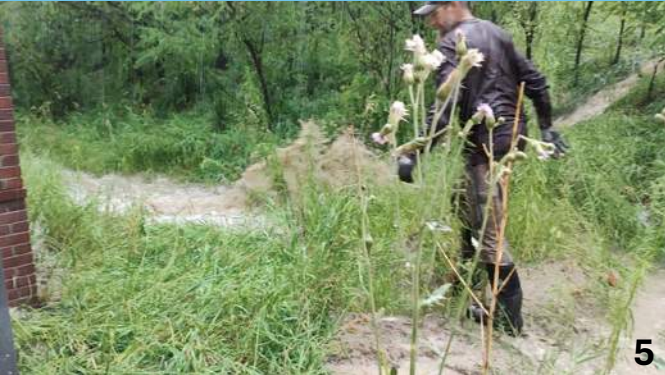
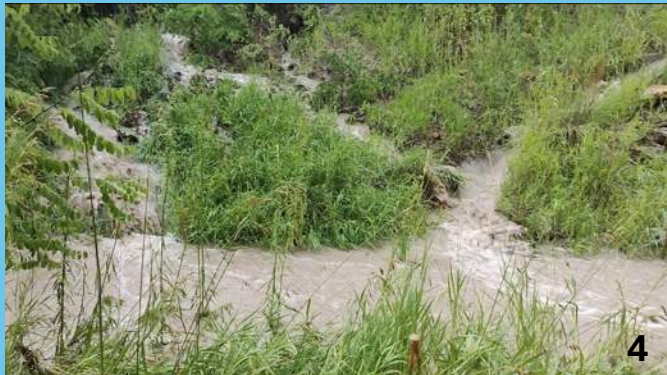
6-inch Area Drain is inadequate to convey flows from +3.5 acres above; Images from 2023 storm video – link in grant text

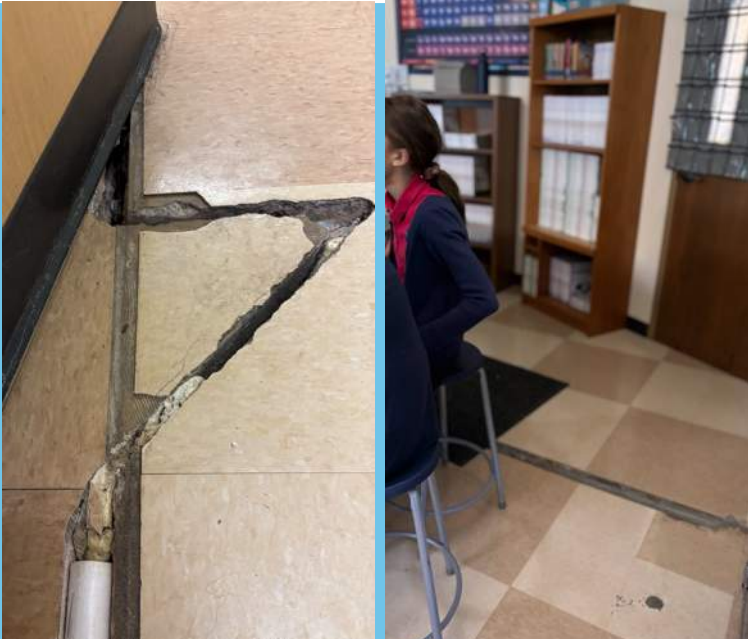
2" wide x 6" deep floor crack in Science Room filled with grout continues to grow in 2025

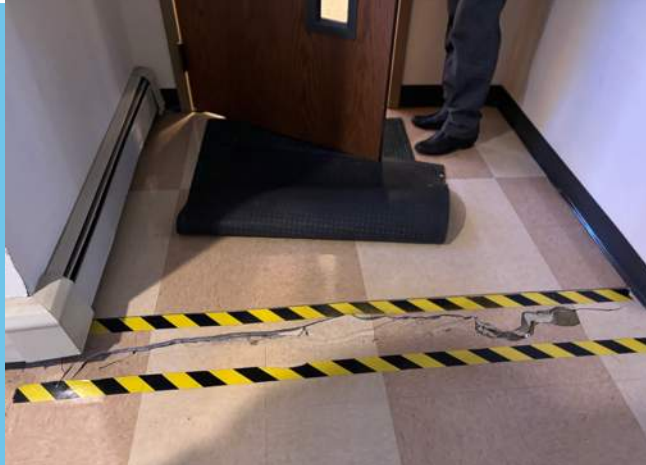
Crack in Middle School hallway continues to fracture slab and increase in size and depth

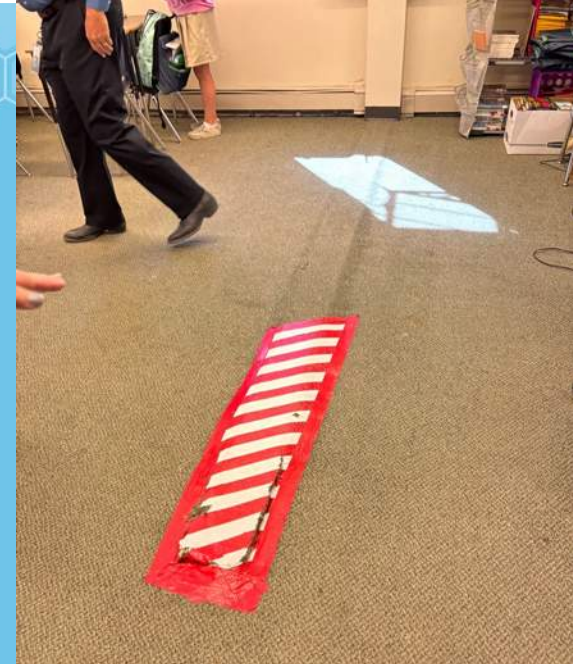
Grade beam protrudes 1" above settled slab, tripping hazard, ADA violation

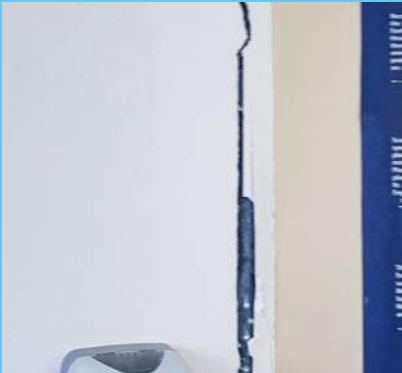
Wall cracks throughout MS

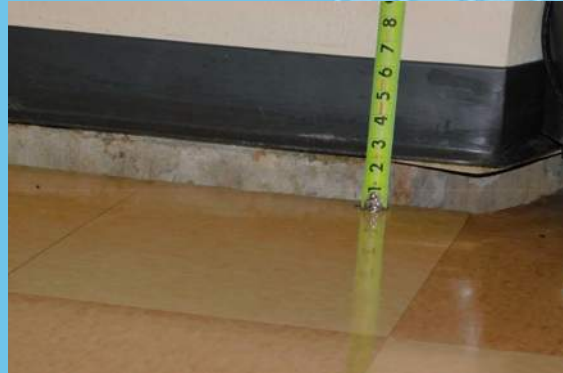
Floor slab settlement over 2 inches

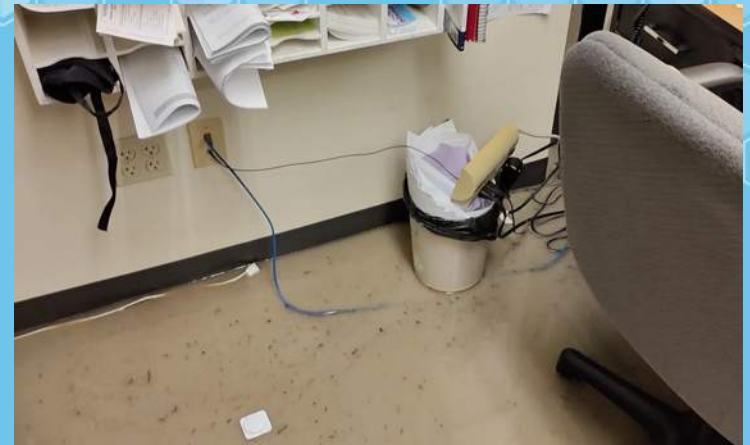
Flood at Middle School 2023

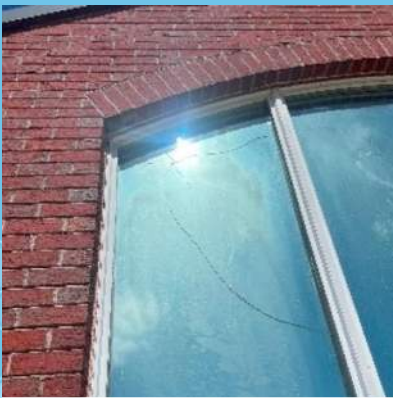
Windows crack due to foundation movement

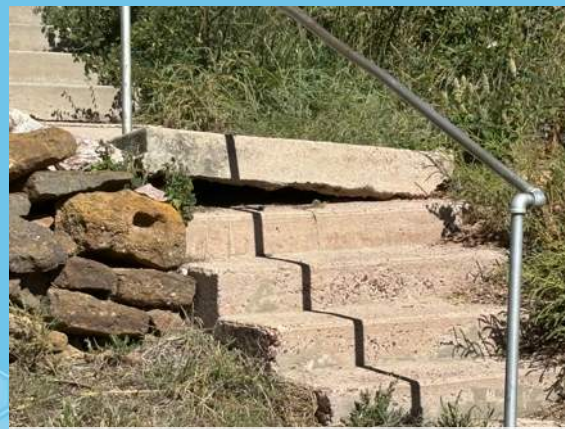
Exterior stair heave

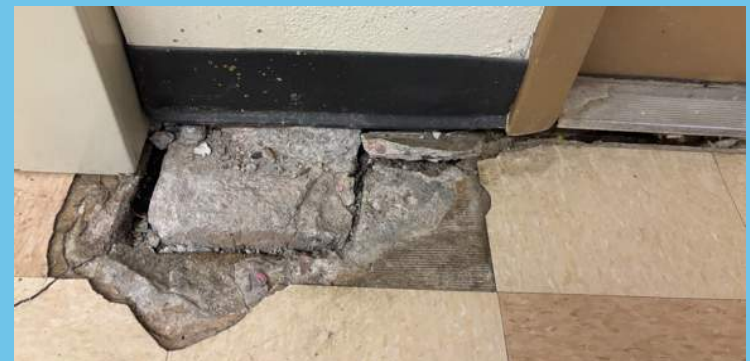
Floor slab distress at Middle School
