**GEOTECHNICAL ENGINEERING CONSULTATION
MIDDLE SCHOOL BUILDING DISTRESS
COLORADO SPRINGS CHARTER ACADEMY
2555 NORTH CHELTON ROAD
COLORADO SPRINGS, COLORADO**

CTL|T Project No. CS19781.000-125

Draft Date April 12, 2024

CTL|Thompson, Inc.

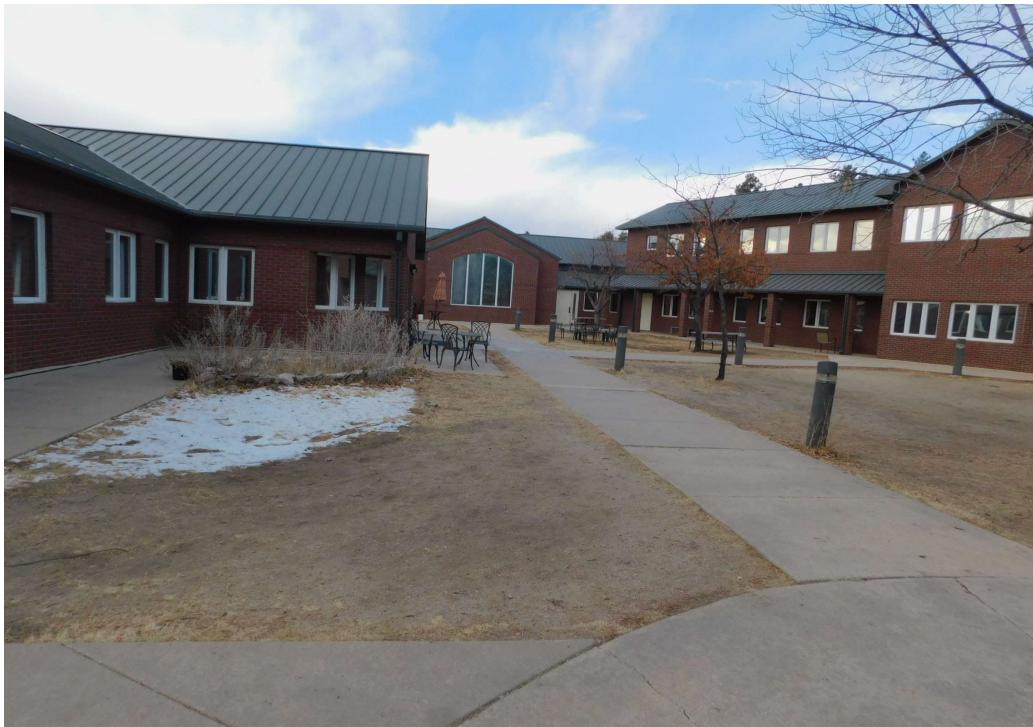
3. Patio/courtyard of Middle School as viewed from near the east property boundary.
Courtyard is generally flat and level. The ground surface is covered with irrigated sod.

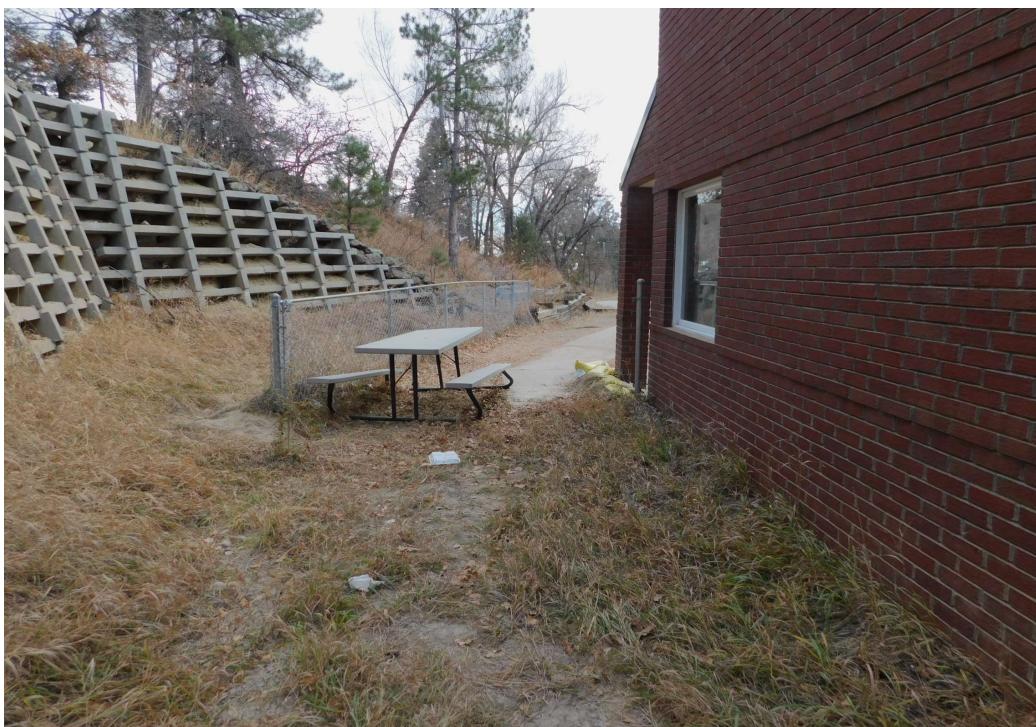
6. East side of the school building viewed from near the northeast side of the school. Crib retaining wall present on the left. East end of the patio/courtyard in the distance.
